## RE: CLARENCE COLLIERY – ADDITIONAL MINING-RELATED DAMAGE

The Lithgow Environment Group Inc (LEG) wishes to notify the Department of the following swamp damage within the Centennial Clarence Colliery mine lease which may be mining-related. These 5 sites are in addition to the 20 sites which LEG notified to the Department on 11 September 2024.

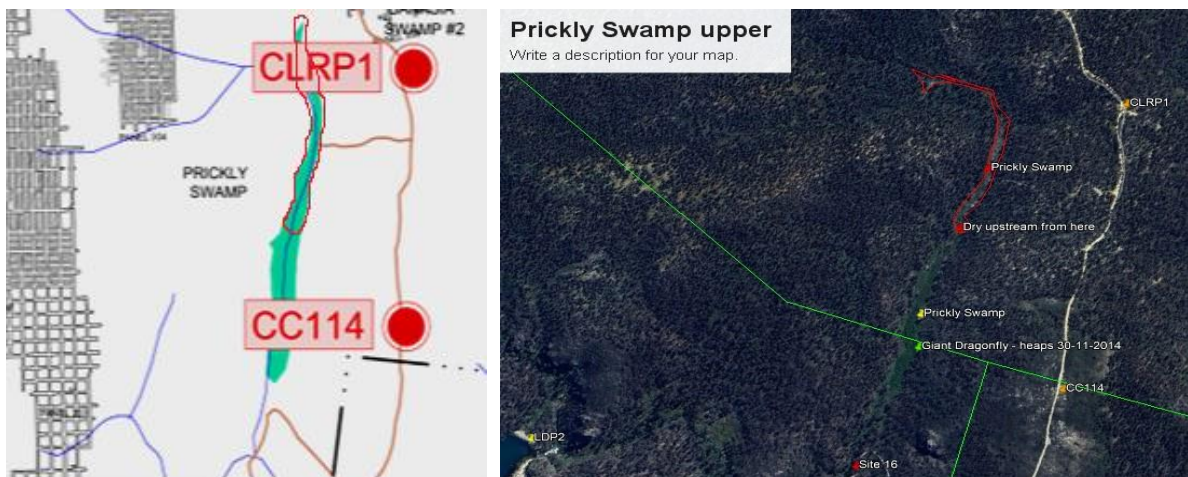
### Site 21: Upper Prickly Swamp Damage (-33.449634, 150.258727)

Prickly Swamp is mapped by Centennial as a Newnes Plateau Shrub Swamp (*Clarence Colliery Annual Environmental Monitoring Report (AEMR) 1 January 2023 to 31 December 2023, Appendix A*). The upper half of this swamp has dried out, and erosion is visible. The first sign of any surface water is at -33.450783, 150.258430. Vibrating Wire Piezometer CLR1 reported “Data gaps exist due to logger issues”. CC114 (VWP) reported “A new logger was installed in October 2021 due to reliability issues.”

Photos 80-82: Maps of THPSS damage to upper Prickly Swamp

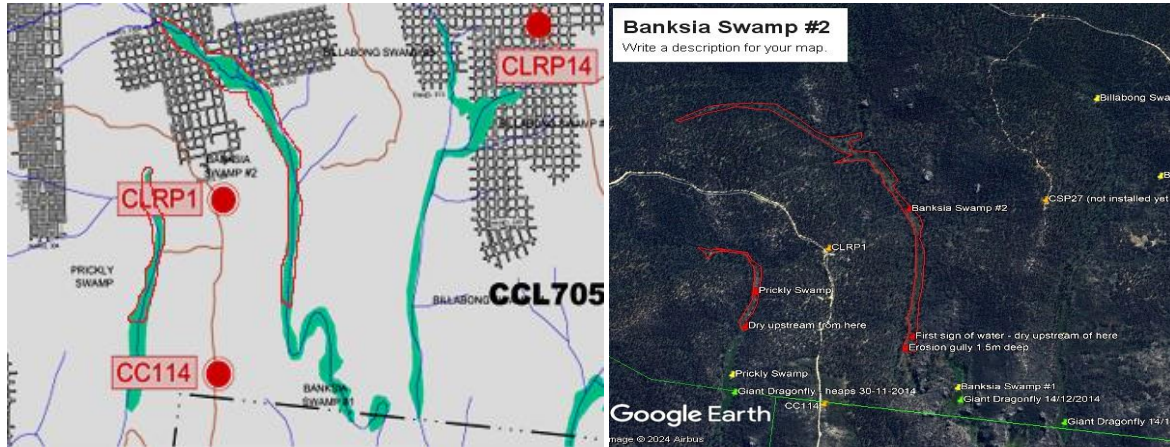
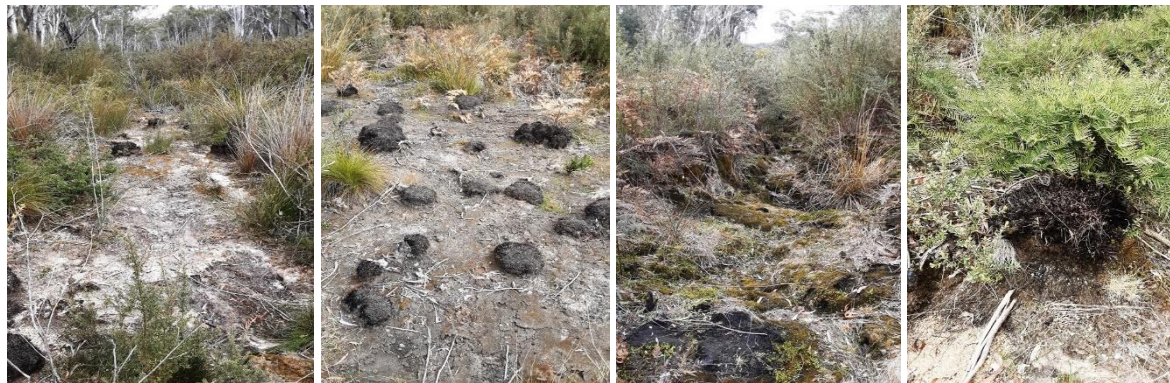
### Site 22: Banksia Swamp #2 Damage (-33.446771, 150.263533)

At least 1km of this swamp was dry at the time of visit. The first sign of any water was at -33.451538 150.263433, and that was 1.5m below the swamp surface in a deep erosion gully. The upper sections of this swamp were undermined by Panel 330 & 332. Mine dewatering may be a contributing factor. Erosion nick-points are forming (eg. -33.451538, 150.263433) and should be monitored/stabilised.

Photos 83-88: Site 22 – Banksia Swamp #2. Dry desiccated THPSS, erosion & nick points starting to occur.

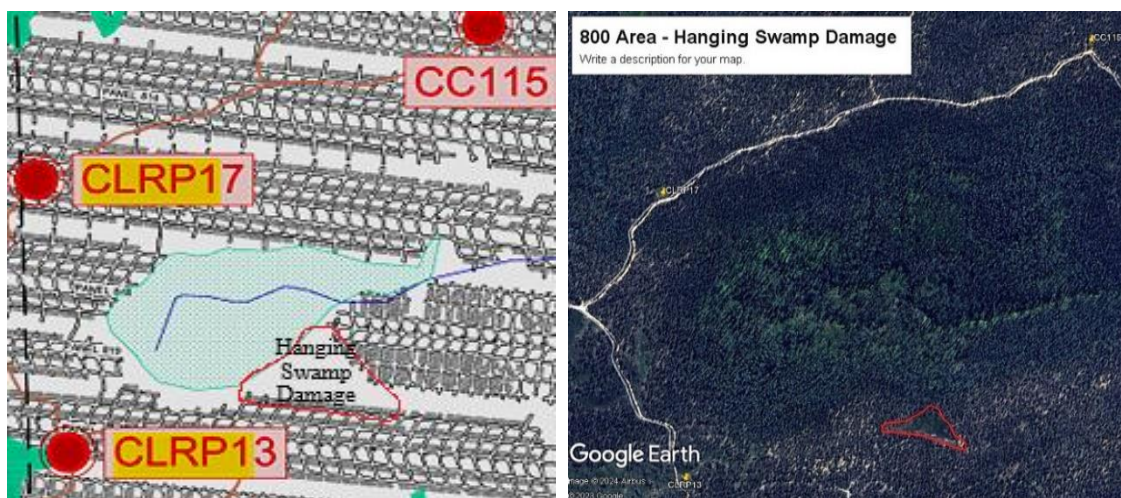
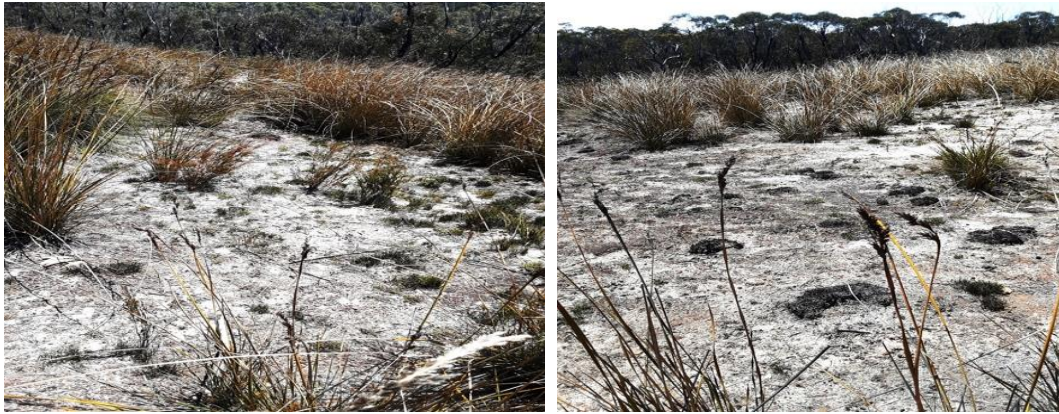
**Site 23: Hanging Swamp Damage – Panel 818A/820 (-33.453466, 150.290740)**

This small MU51 Hanging Swamp is desiccated and showing signs of mining damage. It is about 500m east of CLRP13 on the eastern edge of the diatreme which Panels 818A/820 had to avoid.

Photos 89-92: Site 23: Dead Hanging Swamp in 800 Area ("The Boot") about 500m east of CLRP13

CLRP13 reported 'depressurisation in early May 2022 likely due to mining, and continued decreasing trend during 2023, probably mining related'. CLRP13 overlies Panel 820 which was mined in 2018. 'There are large data gaps at all piezos from October 2018 to July 2021 due to logger issues. Further data gaps exist between 10 February 2023 and 18 April 2023 for Piezo #1 (below MYC). Piezo #5 (above MYC) appears to have malfunctioned in early December 2022.'

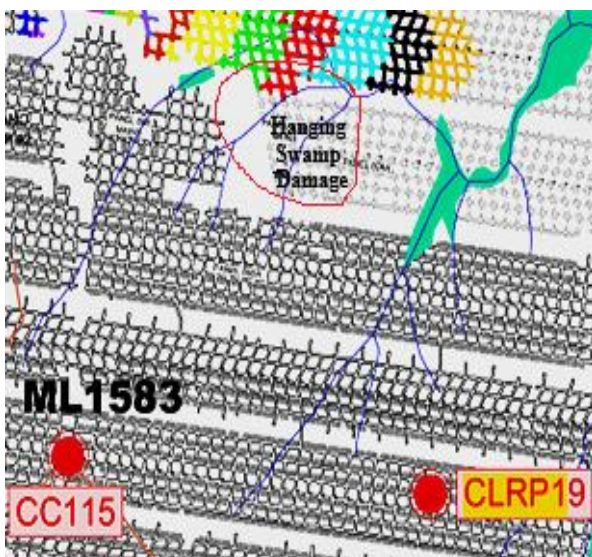
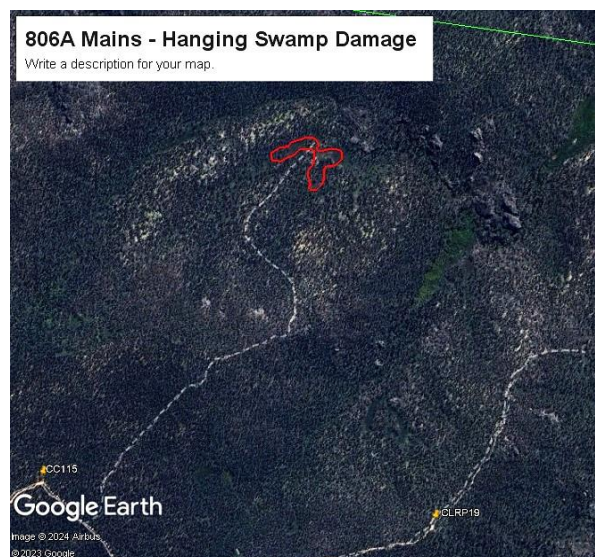
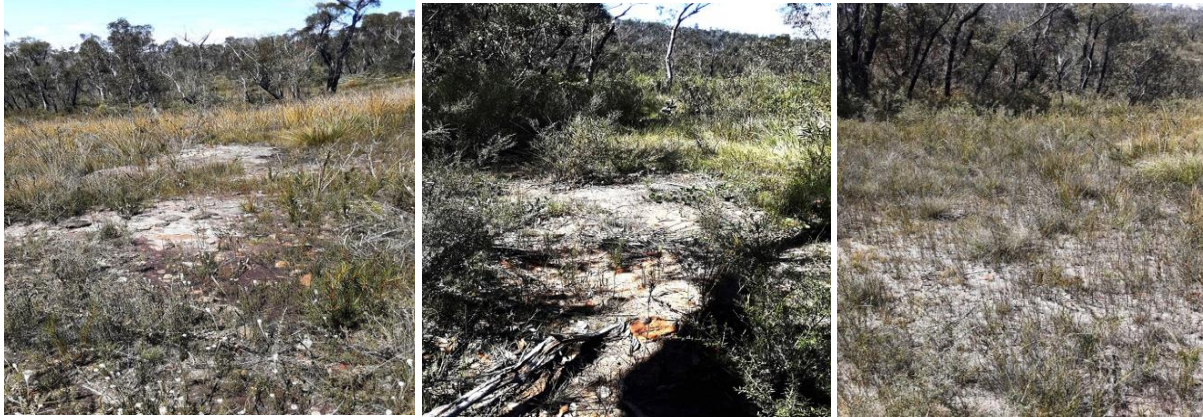
**Site 24: Hanging Swamp Damage - 806A Mains (-33.439578, 150.301448. -33.439431, 150.300625)**

Several Hanging Swamps in this area are showing early signs of deterioration and the creek upstream is dry. Panel 806A is currently being mined. CLRP19 reported "Depressurisation response since August 2021 due to mining Panel 818A. Continued decreasing trend during reporting period." Panel 812 undermined CC115 and all piezos depressurised due to first workings in June 2013. "Further depressurisation was observed in May 2016 following pillar extraction. A depressurisation response in Piezos #1, #2 and #3 (below the MYC) was observed in August 2021 due to mining of Panel 818A. During the reporting period, active mining of Panel 804 and Panel 806A was within 1 km of CC115. Following initial depressurisation observed in 2021, Piezos #1, #2 and #3 continue to show a decreasing trend".

Photos 93-97: Site 24: Damaged Hanging Swamps Panel 806A Mains, 800 Area ("The Boot")

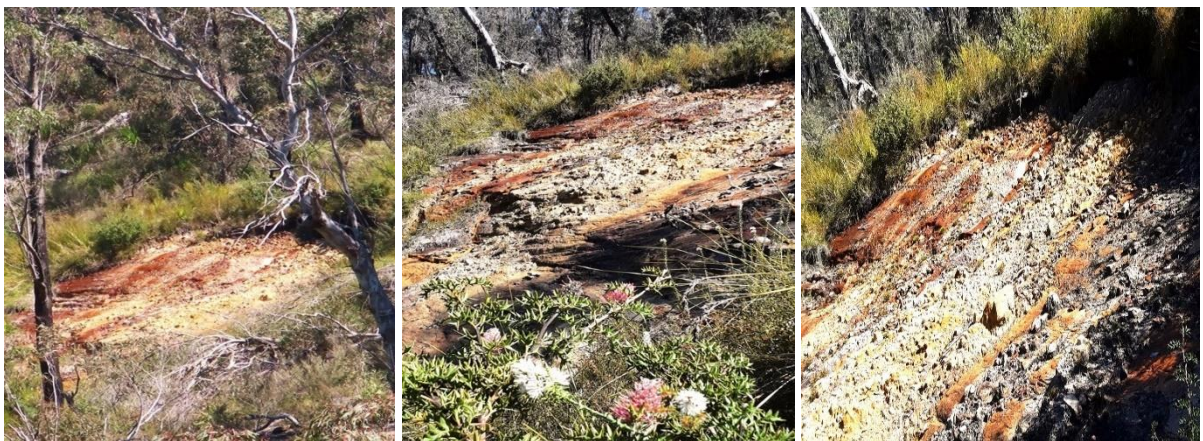
**Site 25: Hanging Swamp collapse, GBMWA boundary east of REA3 (-33.461881, 150.258171)**

This small Hanging Swamp collapse above the Wollangambe River on the GBMWA boundary is fairly recent, and based on historic Google Earth imagery occurred sometime between July 2021 and September 2023. Whilst it may not be mining related, it is only 400m east of Clarence Colliery REA3.

Photos 98-101: Site 25 Hanging Swamp collapse above Wollangambe River on GBMWA boundary
