# Lithgow Environment Group Inc.

11 September 2024

## **RE: CENTENNIAL CLARENCE COLLIERY – MINE SUBSIDENCE DAMAGE**

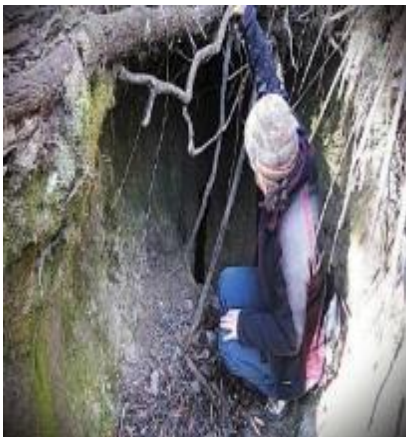
First recorded July 2010, last sighted April 2024. Large sinkhole 200m long x 10m wide x 2m deep with a 150-250mm wide subsidence crack at its eastern end. The crack runs east-west across a northerly flowing tributary of Bungleboori Creek. All surface water that once flowed down this creek now flows down that crack, and the creek and THPSS downstream are totally dry. Groundcover vegetation has not recovered in 14 years of observation, with many bare and denuded areas.

Photo1: Site 1 Crack in sinkhole - July 2010

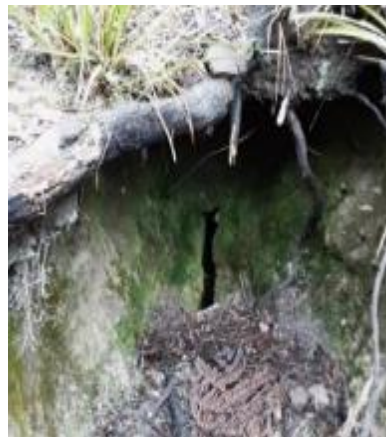
Photo2: Site 1 Crack in sinkhole June 2024

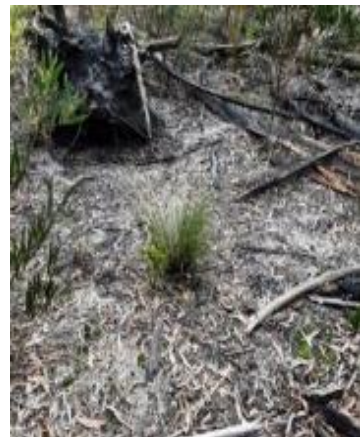
Photo 3: Dry creek downstream 2024

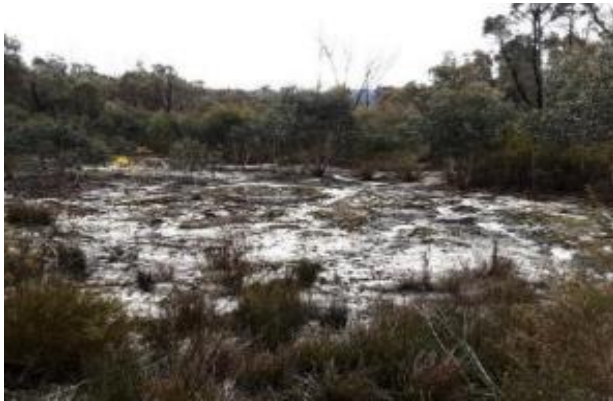
First recorded July 2010, last sighted April 2024. Dead THPSS extending 300m downstream with dead Hanging Swamps along verges. Visible on Google Earth. White sand/peat with dead *Leptospermum grandifolium* and *Lepidosperma limicola* stumps. Very little natural regeneration has occurred over 14 years, as the creek is totally dry. Nature doesn't appear to know how to heal desiccated peat swamps.

Photo 7: Site 2 Damaged THPSS – June 2024

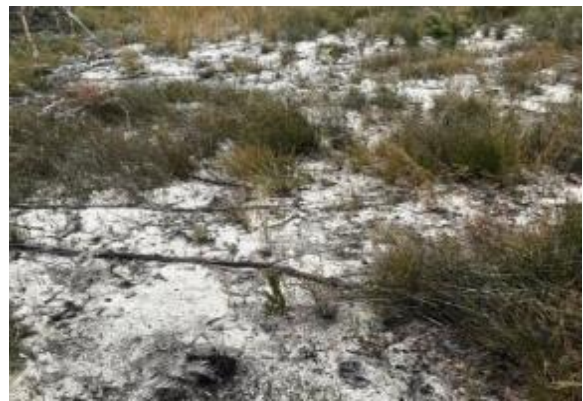
Photo 8: Site 2 Damaged THPSS – June 2024

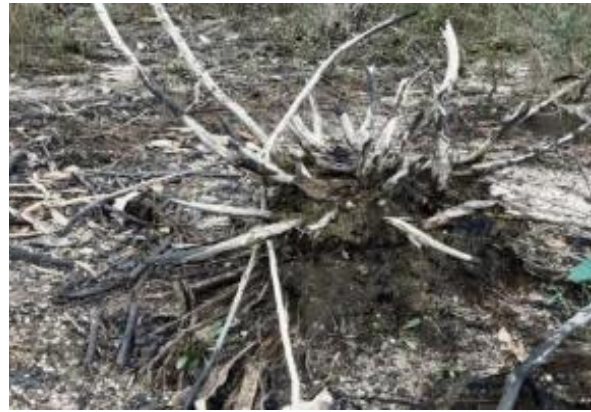
Photo 12: Remnant *Leptospermum* stump in dead THPSS

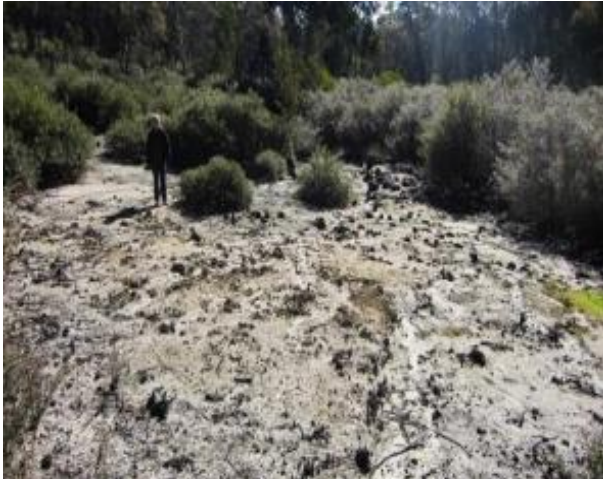
First recorded July 2010, last visit June 2024. At least 400m of this THPSS is dead (entire length not walked), and dead Hanging Swamps occur along the verges. Severe erosion downstream has liberated 1000s of tonnes of silt which will end up in Bungleboori Creek and ultimately the GBMWHA.

Photo 13: Site 4 Dead/Damaged THPSS - July 2010

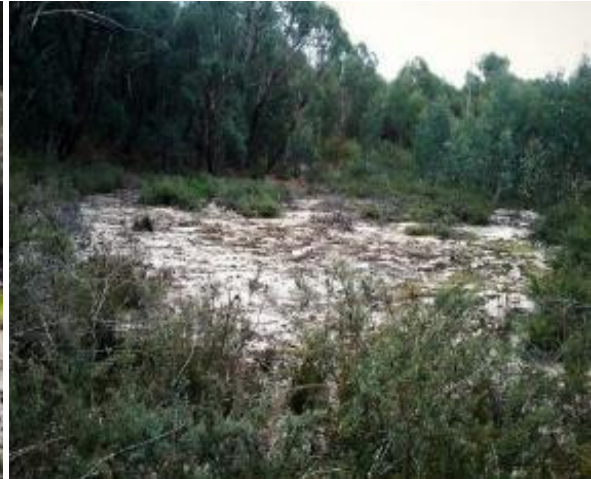
Photo 14: Dead/Damaged THPSS – June 2024

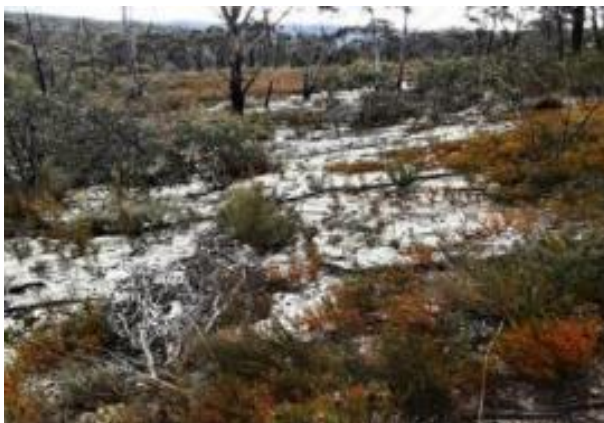
First recorded July 2010, last visit April 2024. Damaged THPSS Hanging Swamp extending 240m or more along a slope below a ridge. Occasional bare patches further downhill towards swamp in creek.

Photo 15: Site 5 Damaged Hanging Swamp - June 2024

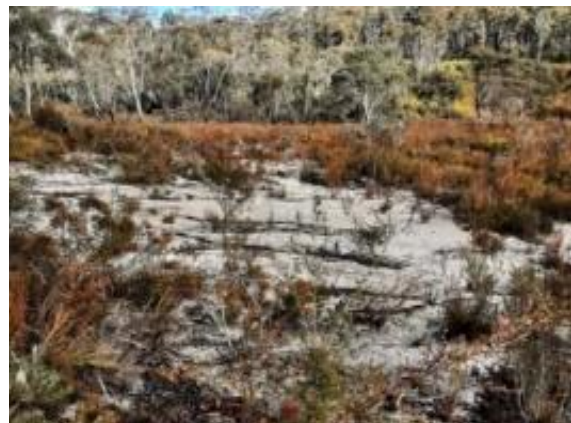
Photo 16: Site 5 Damaged Hanging Swamp – June 2024

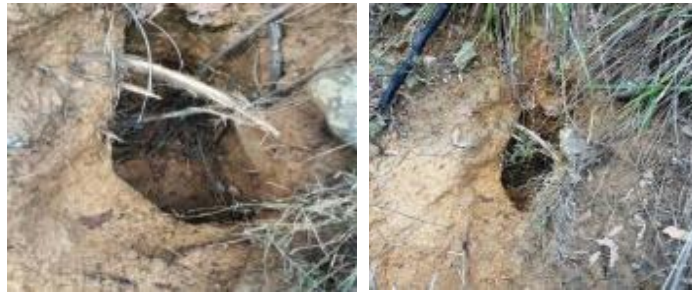
Recorded June 2024. A subsidence crack 600mm long x 300mm wide running east-west along an old motorbike track. Water flowing down the track is funnelled underground. LEG notes the IESC Advice on the Clarence Colliery Extension (EPBC 2012/6446) on 31 July 2012 - *“The IESC committee notes that the design adopted by Clarence Colliery is expected to limit the subsidence to less than 100 mm, with tilts and strains less than 2 mm/m and 1 mm/m respectively, and that to date, no surface cracking has been observed above Clarence Colliery.”* No surface cracking??? (see also Site 1 above).

Photo 17 & 18: Site 6 Mine Subsidence Crack 600mm x 300mm – June 2024

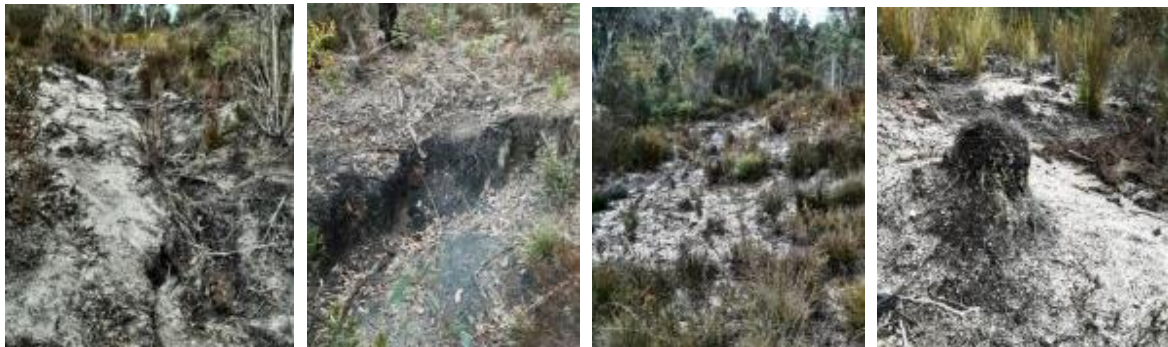
First recorded October 2008, last visit June 2024. Dead Hanging Swamp, more damage upstream. Little has regrown in 16 years as the creek and swamp are totally dry. Severe erosion & siltation.

Photo 19-22: Site 7 Dead THPSS Hanging Swamp with more damage upstream – after 16 years little has regrown – June 2024

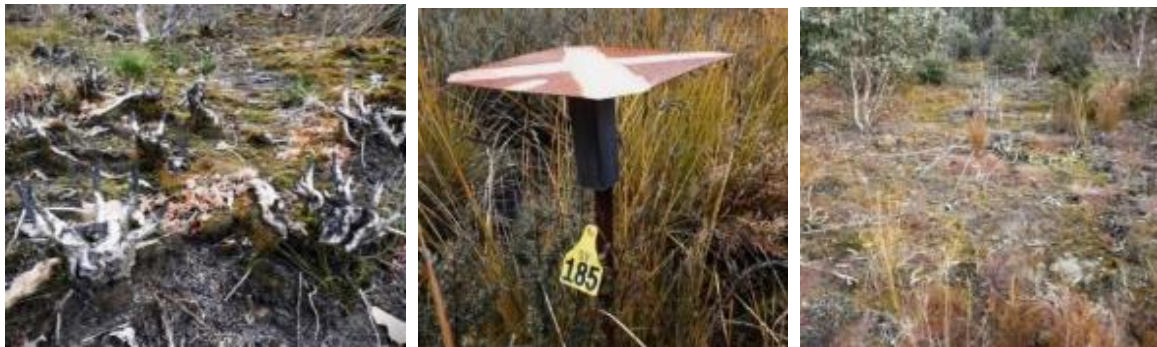
Clearly Upper Paddys Creek Swamp was drained by Panel 909, and subsequently damaged by the December 2019 fire. This damage is only a short distance from vegetation monitoring points SV184 & 185 and Centennial must have been fully aware of it. Why wasn't this THPSS damage reported?

Photo 23, 24, 25: Site 8 – Upper Paddys Creek Swamp, Panel 909. Damaged THPSS, SV185, & limited recovery after fire

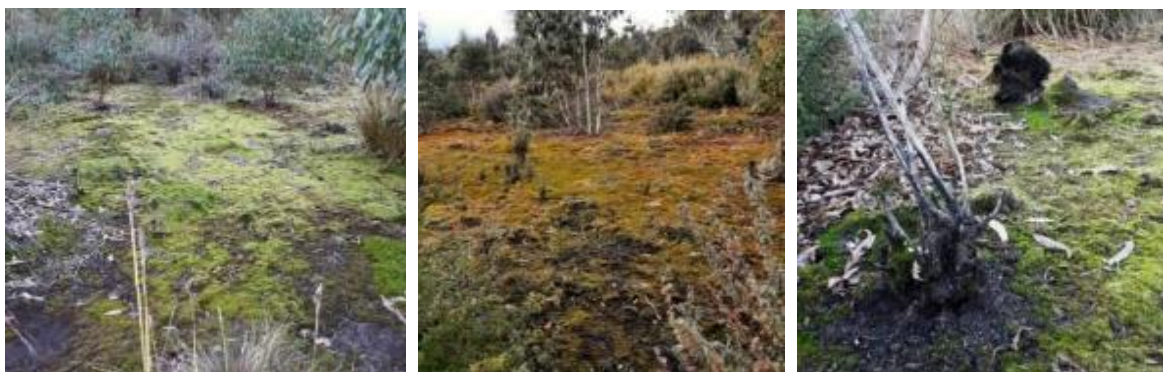
Photos 26, 27, 28: Site 8 - Upper Paddys Creek Swamp, Panel 909. Moss but little else regenerating 4.6 years after fire.

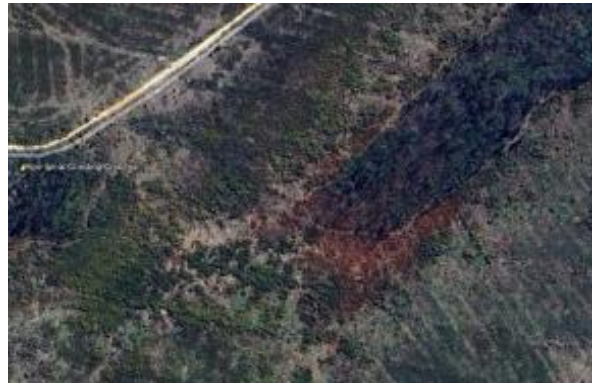
Photo 31: Site 10 Google Earth Imagery August 2023

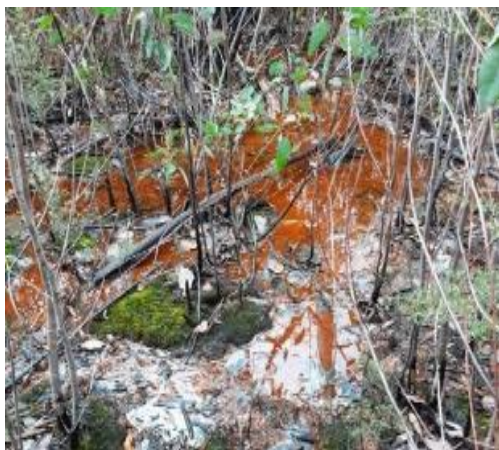
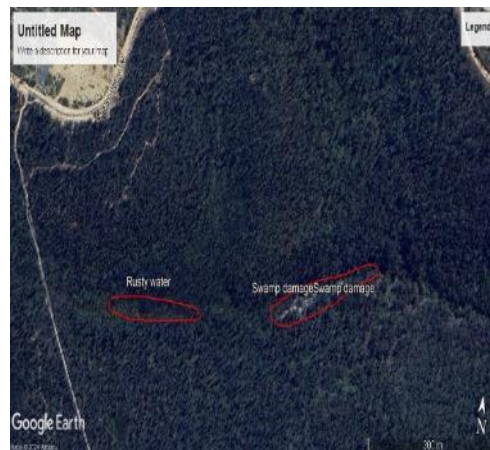
In addition the water has a distinct rusty-red discoloration not sighted in nearby creeks. This is not unlike Lambs Creek in the Angus Place 300 Area where subsidence cracks allow vertical groundwater flow from upper aquifers into incised valleys, picking up oxidizing sulphuric minerals along the way.

All coal seams slope downhill in a north-east direction, Panel 414/Longwall 4 are the lowest Clarence mine workings, and it is plausible that minewater seepage contaminated with Iron, Manganese, Nickel etc is resulting in metal pollution of Bungleboori Creek which flows into the GBMWHA – a MNES.

Photo 32 & 33: Site 1 1- Rusty-red discoloured water & swamp damage Longwall 1 – June 2024

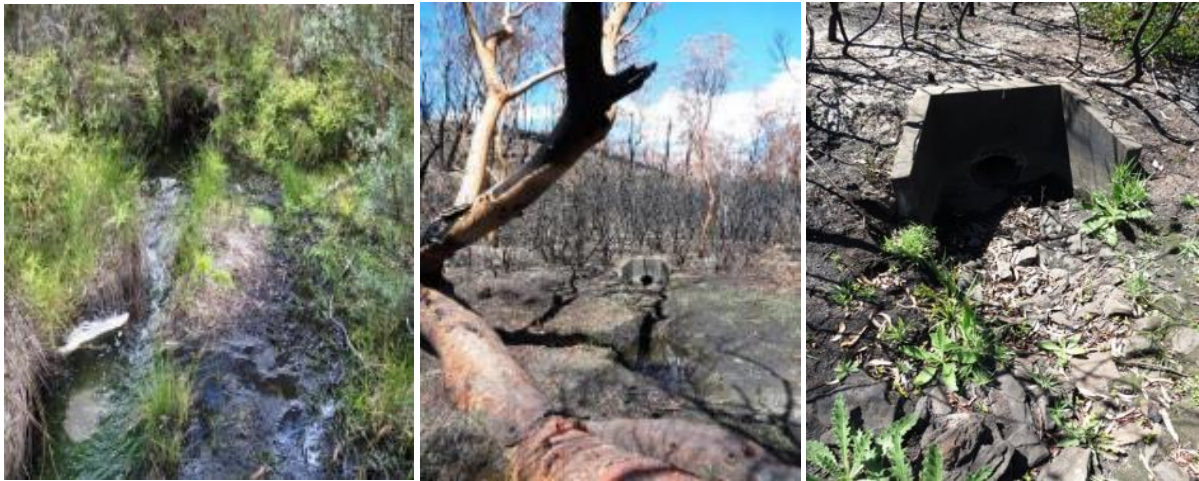
Farmers Creek South Swamp was drained by Clarence Colliery Panel 707 in 2012 and subsequently severely damaged by the State Mine Fire in October 2013. Previous damage had occurred due to the Clarence Water Transfer Scheme (CWTS) discharge point (33.456013, 150.222956).

*Photos 34,35,36: Site 12 - CWTS Discharge Point into Farmers Creek Swamp on 31 January 2010, and after the 2013 fire.*

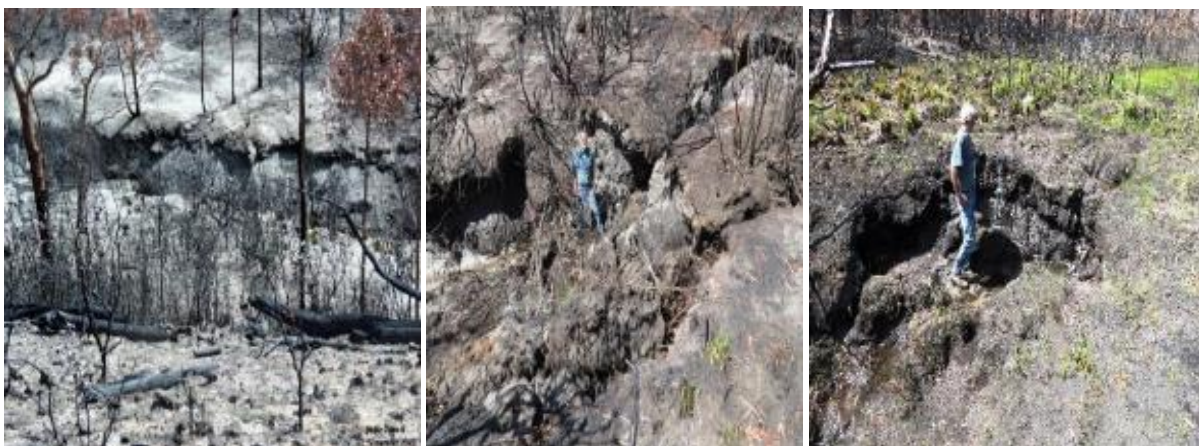
*Photos 40, 41, 42: Site 12 – Erosion, scouring, slumping after undermining by Panel 707 and State Mine Fire – 24 November 2013*

That work was completed in August 2013, however just 8 weeks later was partly destroyed by the October 2013 State Mine Fire which melted poly pipes that had been laid above-ground. Meanwhile damage due to undermining of this swamp by Panel 707 slipped under the radar.

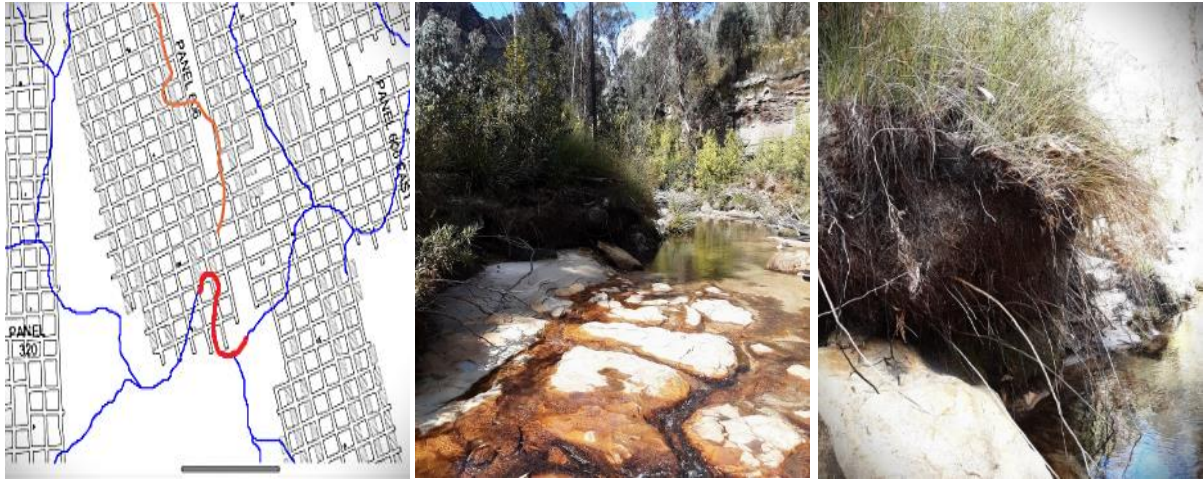
*Fig 3: Panel 606 creek damage(Red) Photo 45 & 46: Bungleboori Ck under-cutting bank & forming new channel*

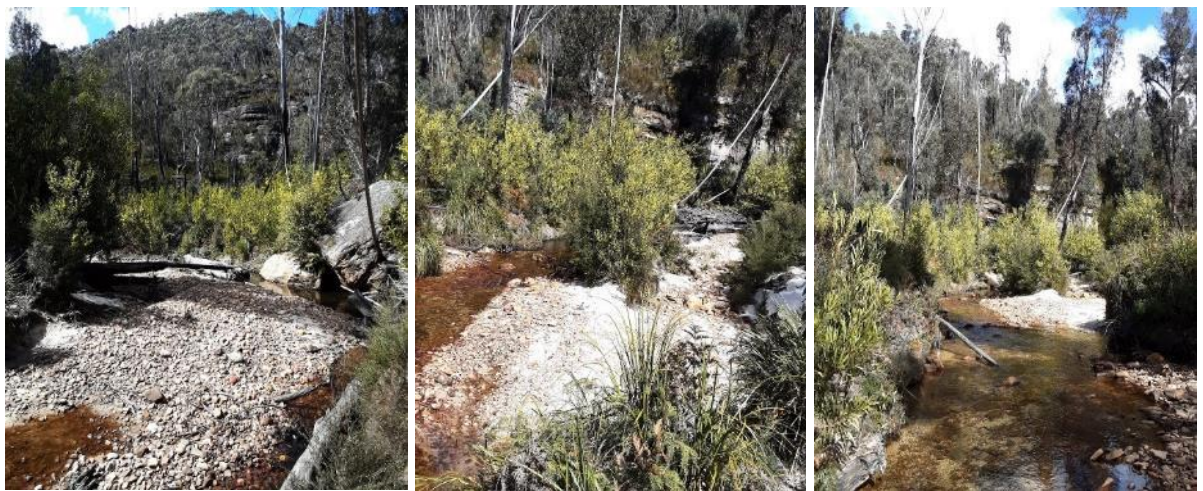
*Photo 47, 48,49: Bungleboori Creek tilted by Panel 606, abandoning old channel, and forming new channel*

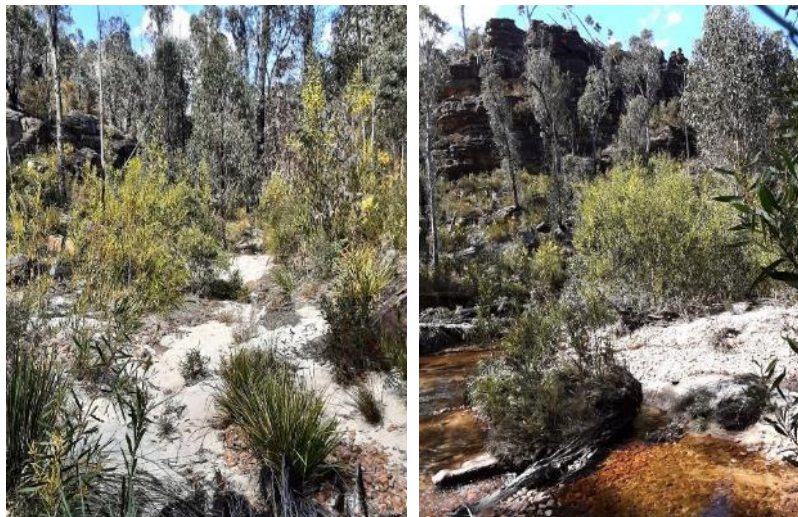
*Photo 50 & 51: Bungleboori Creek tilted by Panel 606 & forming a new channel*

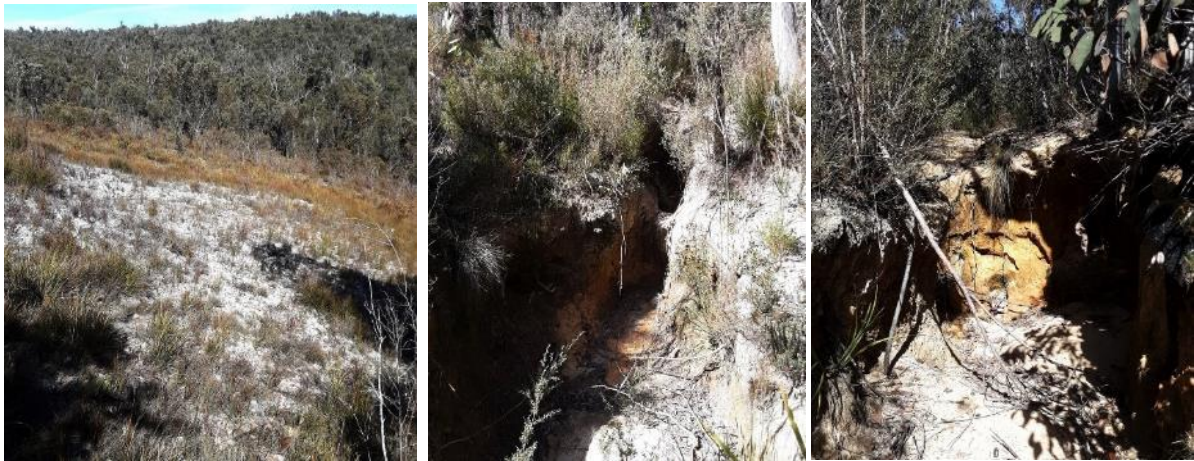
THPSS Hanging Swamps above Panel 308 have died, the entire length of the creek for about 1km to its junction with Bungleboori Creek has dried up, there are possible sinkholes, and severe erosion.

Photo 52-55: Site 14 - Dead hanging Swamps, dried up creek, possible sinkholes, severe erosion

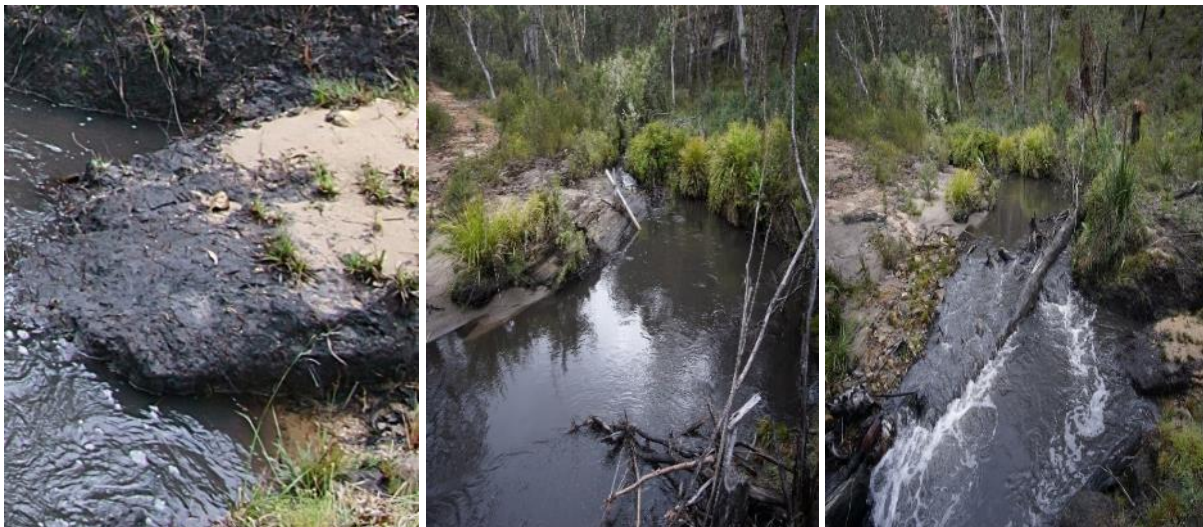
The Clarence Colliery coal-fines spill into the Wollangambe River on 22 December 2023 was reported by LEG, not by Centennial. This highlights an ongoing issue with Centennial mines in the Lithgow area - failure to report incidents of environmental harm.

*Photos 59-61: Clarence Colliery coal-fines spill into Wollangambe River – 22 December 2023*

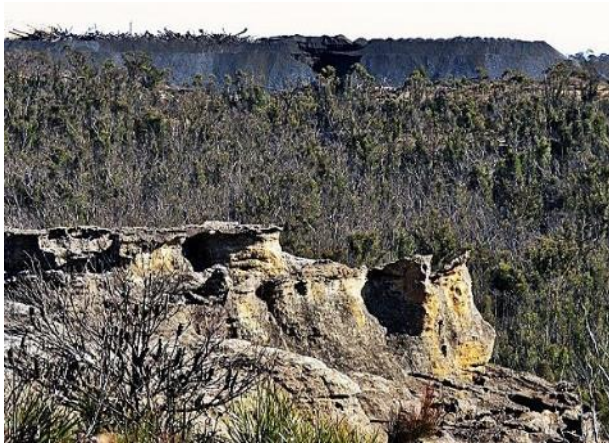
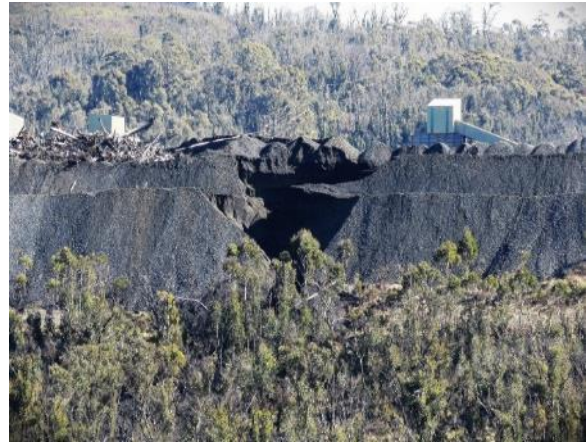
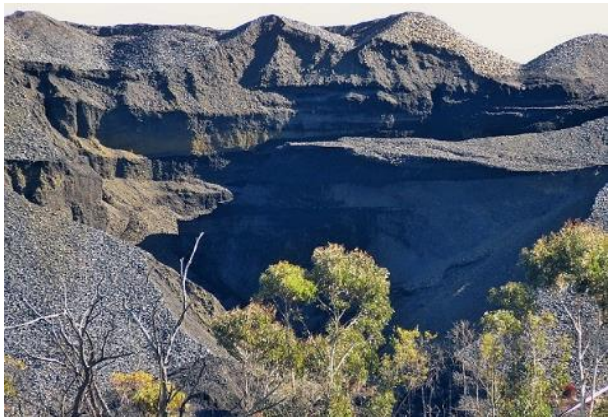
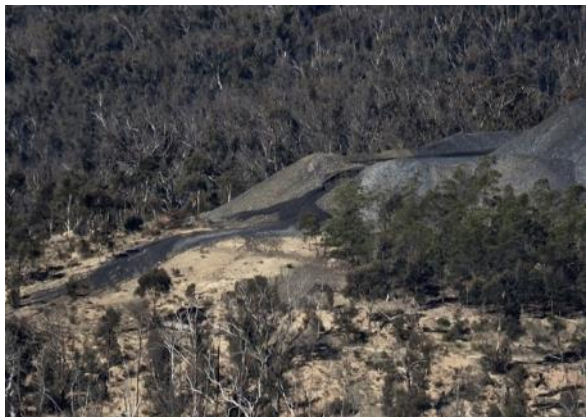
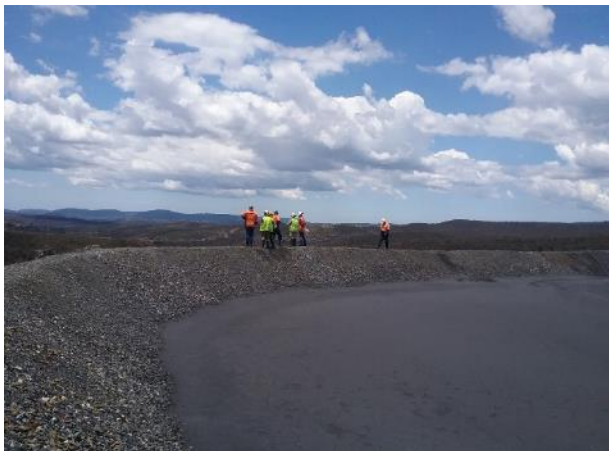
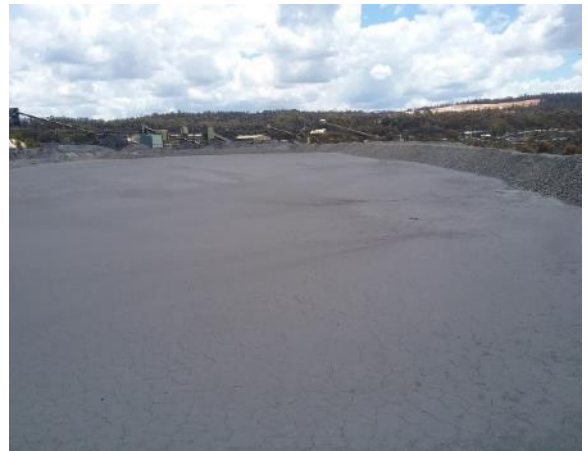
On 2 July 2015 part of the eastern wall of Reject Emplacement Area (REA) 3 failed resulting in the release of coarse reject and 2,330 tonnes of coal fines into the Wollangambe River & GBMWHA. The Land & Environment Court convicted Clarence Colliery P/L of two offences and imposed financial penalties totalling \$1,050,000 plus \$106,010 in investigation and legal costs - the single largest fine following prosecution by the EPA.

Photo 62-69: Clarence Colliery Reject Emplacement Area ("REA") 3 – collapsed on 2 July 2015

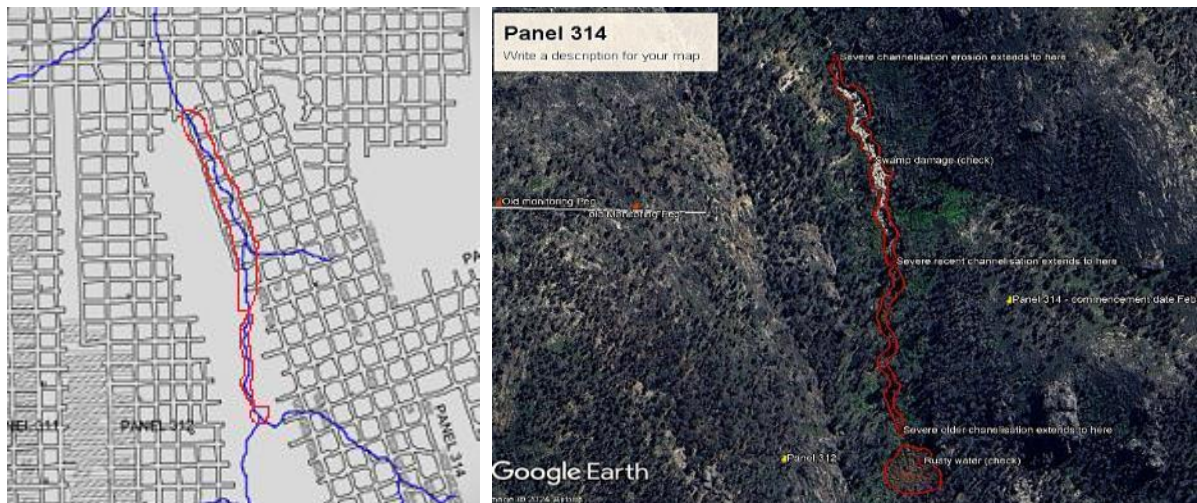
This is the most severe channelisation and erosion LEG has seen on Newnes Plateau. The most recent damage is clearly visible on Google Earth, extending for 200m and up to 20m wide x 4m deep. It corresponds almost exactly to where Panel 314 passed underneath this creek. Remnant *Olearia quercifolia* and other swamp species suggest THPSS or Hanging Swamps once occurred pre-mining.

Photo: 76 & 77 Clarence Colliery Panel 314 – Severe channelisation, erosion & dried-up creek in former THPSS

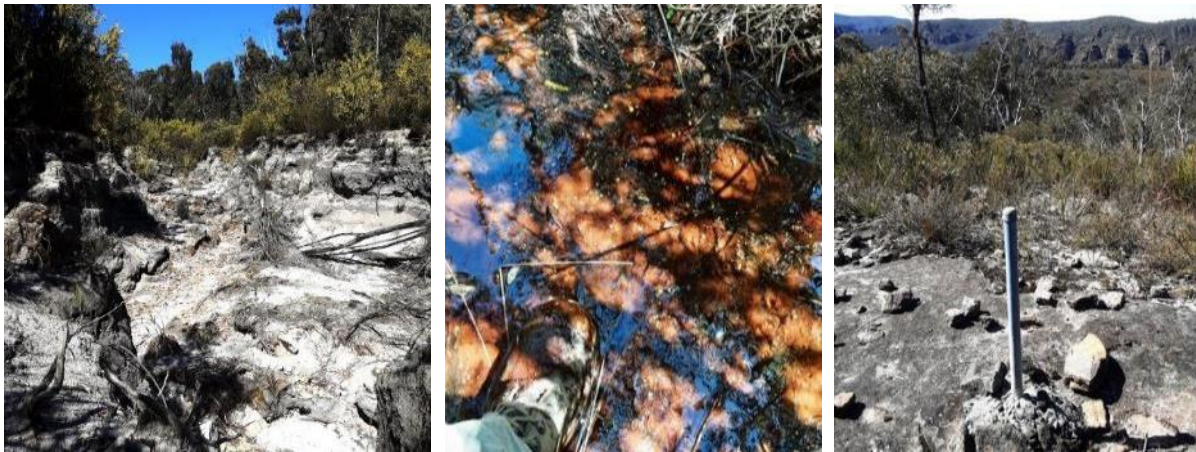
Older channelisation and erosion extends a further 150m upstream, near to a patch of rusty-red water visible on GoogleEarth, possibly minewater seepage, which disappears underground. Old pegs along a subsidence monitoring line occur on the ridge to the west. LEG believes the initial damage was caused by early 300 Panels (Wongawilli Full Extraction), and reactivated by Panel 314 post 2010.

Photo 80-82: Panel 314 – Severe channelisation, erosion, rusty-red discoloured water, old mine subsidence peg

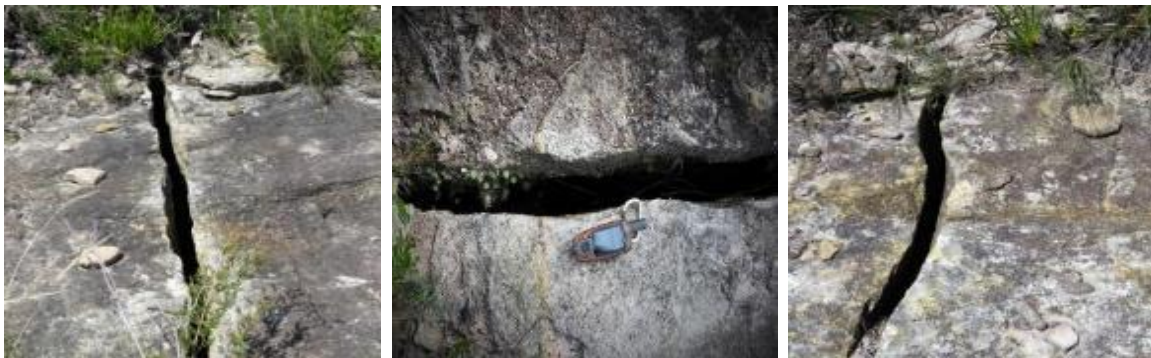
Photo 1, 2, 3: Mine subsidence cracks on Kamarah Ridge and Jungaburra Ridge above Canyon Colliery – 10 February 2015

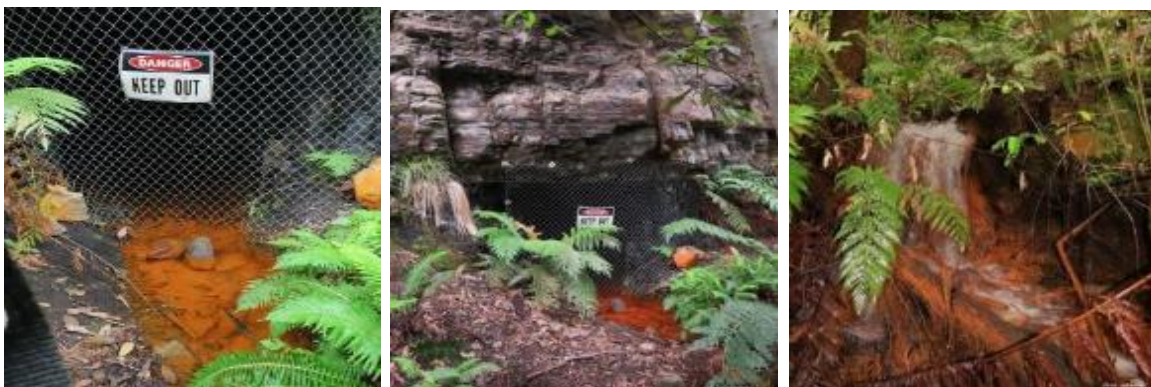
Photo 4, 5, 6: Contaminated mine water discharge from Canyon Colliery into Dalpura Creek and GBMWhA – 5 May 2015

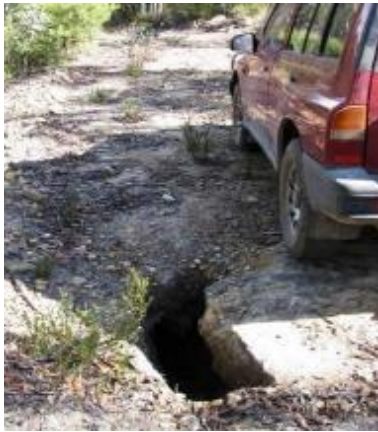
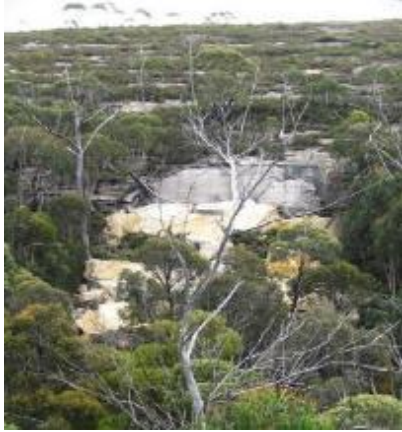
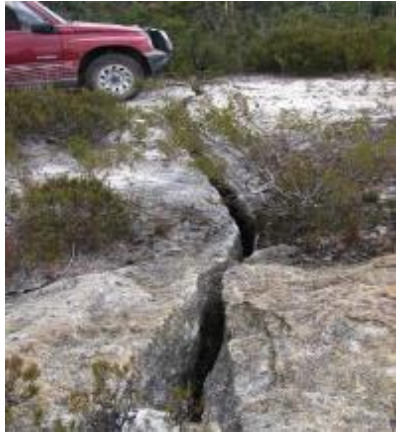
Photos: Cliff fall and subsidence cracks on Newnes Plateau above Cobar Park Colliery bord & pillar workings – March 2009

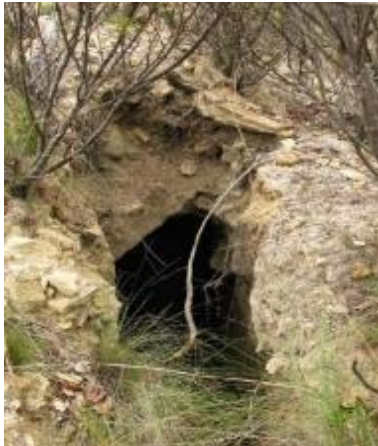
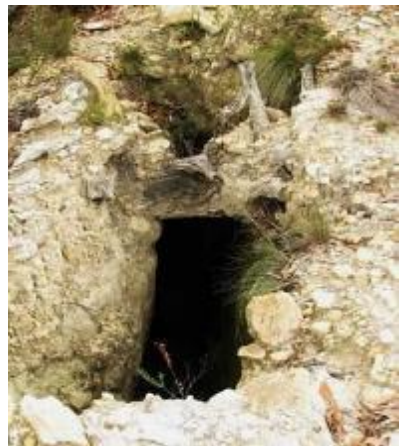
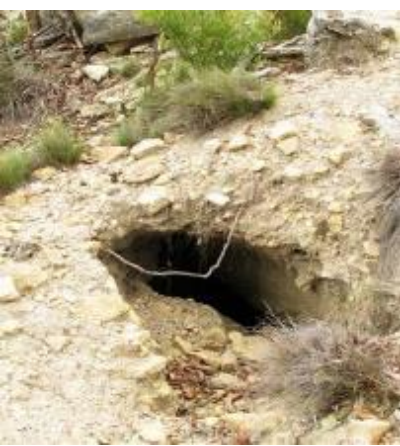
Photos: Subsidence cracks on Newnes Plateau above Cobar Park Colliery bord & pillar workings – March 2009

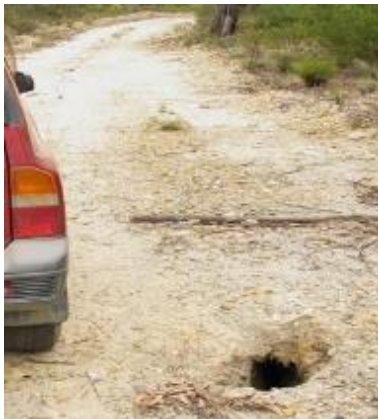
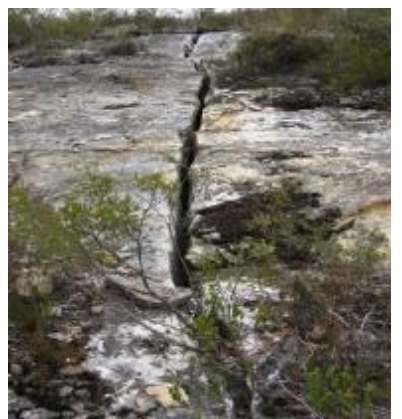
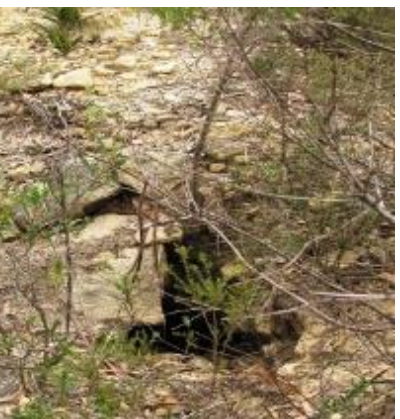
Photos: Subsidence cracks on Newnes Plateau above Cobar Park Colliery bord & pillar workings – March 2009

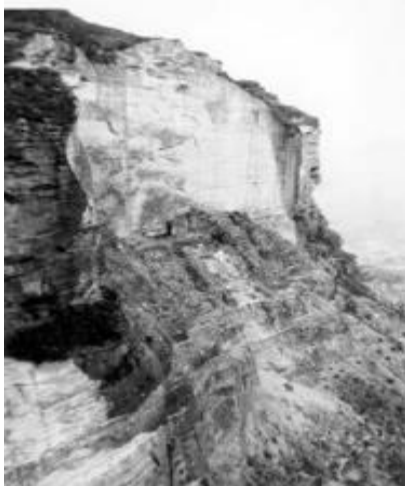
Photo 1: Cliff Fall - Hassans Walls 1960s

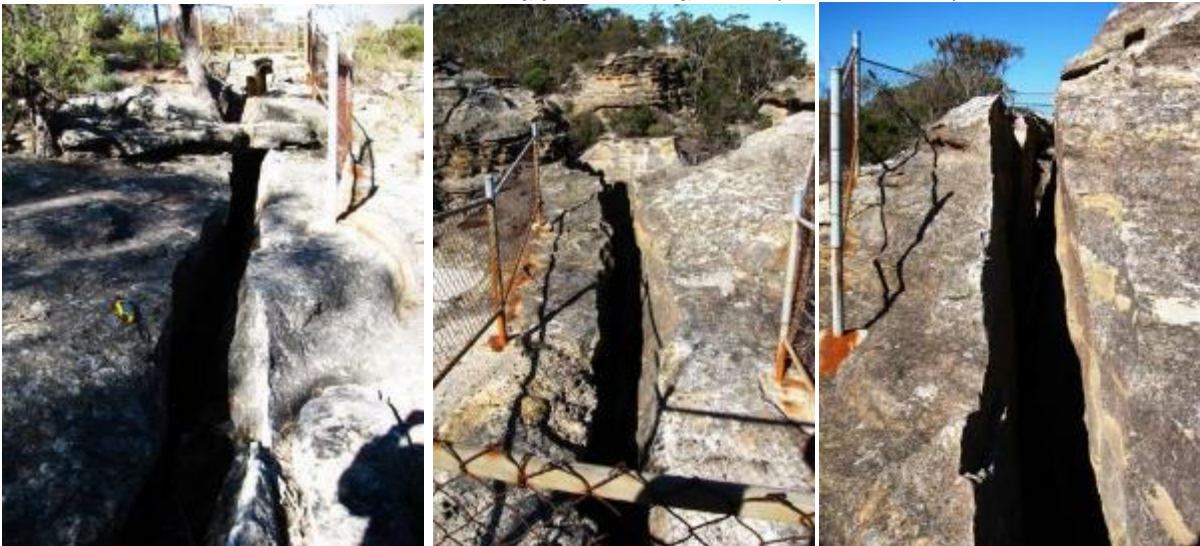
*Photos 13, 14, 15 - Mine subsidence cracks – Hassans Walls Reserve – May 2009*

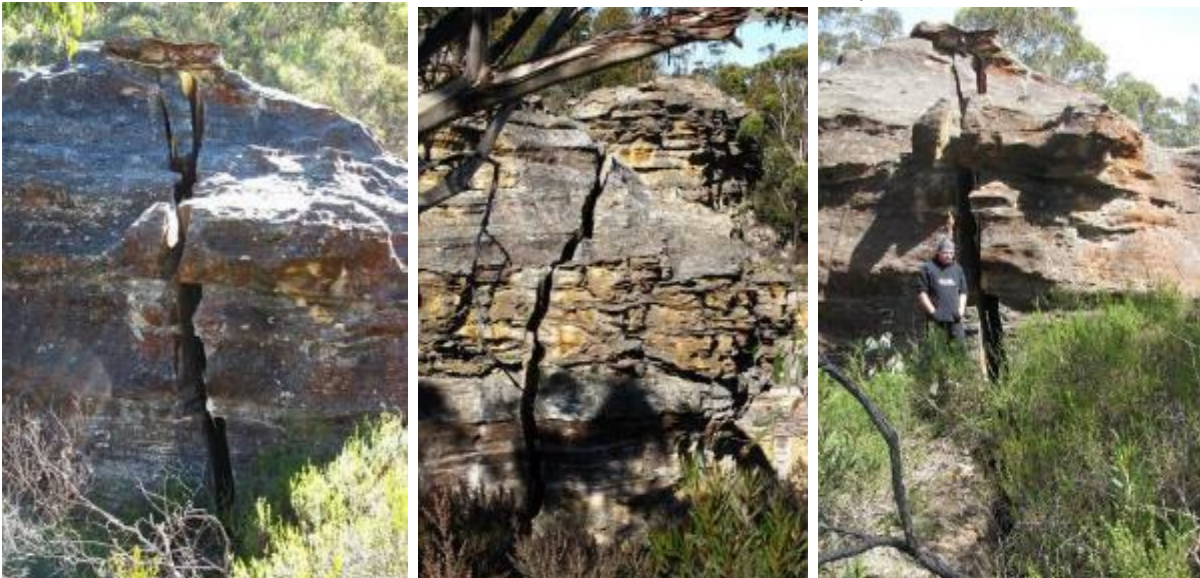
*Photos 16, 17, 18 - Mine subsidence cracks – Hassans Walls Reserve – May 2009*

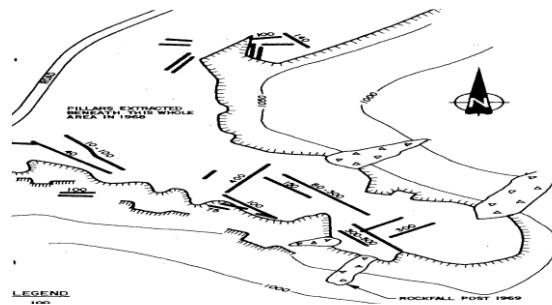
Major cracking has occurred within the Reserve with open fissures up to 0.5m wide. Four rock falls occurred, the first two before 1969 and two smaller ones either in 1970 or 1971. Crack monitoring has continued in the area up to the present time and this shows that some of the cracks are continuing to open and there is some evidence of further rock falls in the vicinity of the four large collapses.

Figure 1: Hassans Walls Reserve Mine Subsidence (Pellis 1991)

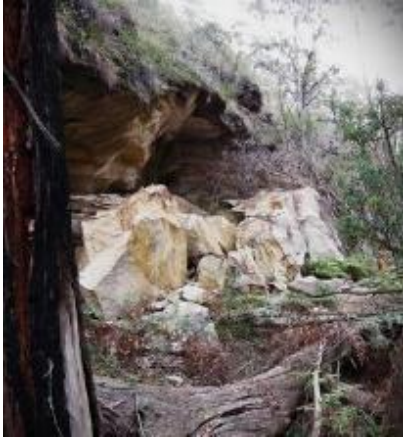
Photo: Cliff fall Invincible 14 March 2013

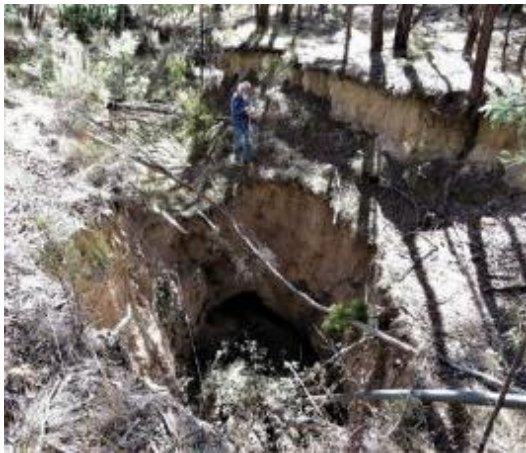
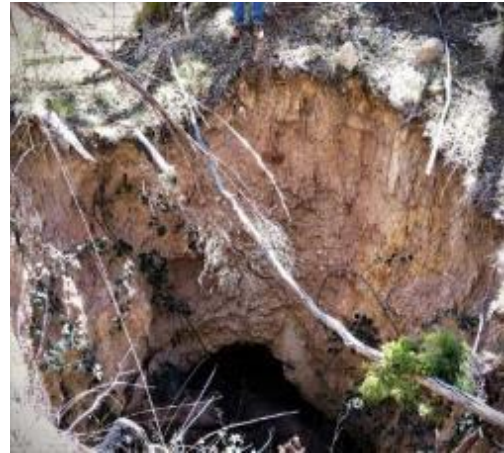
Photos: Invincible Colliery – Creeks disappearing down subsidence cracks into mine void – 19 August 2017

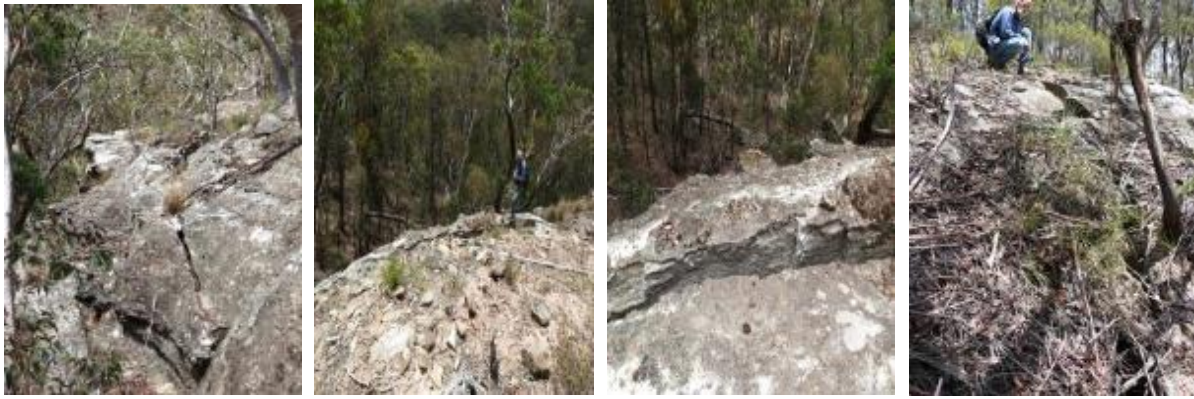
*Photos: Subsidence cracks – Invincible Colliery Bord & Pillar/partial extraction areas*

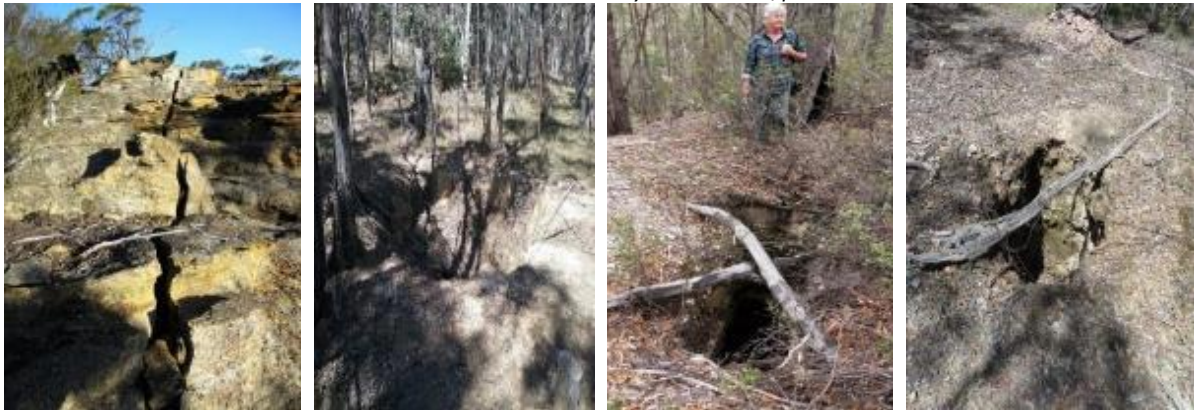
*Photos: Invincible Colliery mine subsidence damage to pagodas, sinkholes, and open mineshafts*

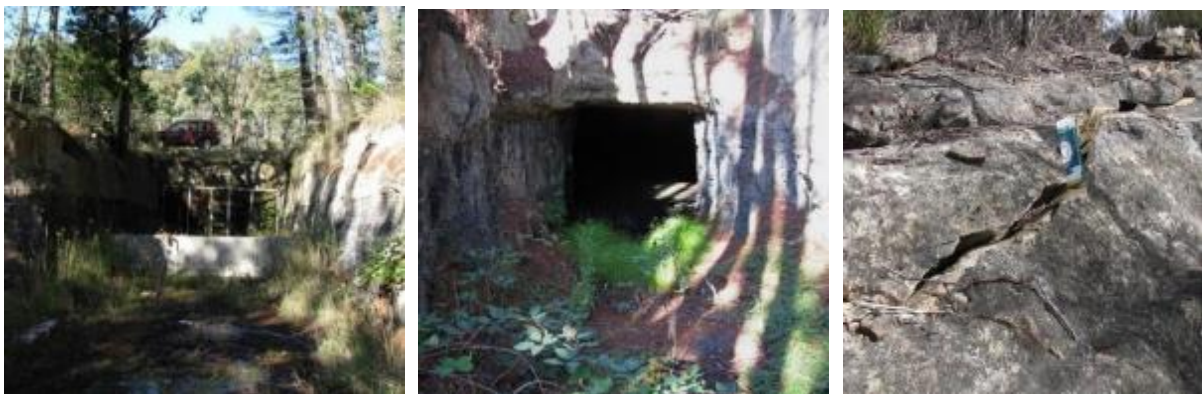
*Photos: Ivanhoe Colliery – old mine drifts allow water to flow SW under Boulder Rd to Pipers Flat Creek & Coxs River – March 2010*

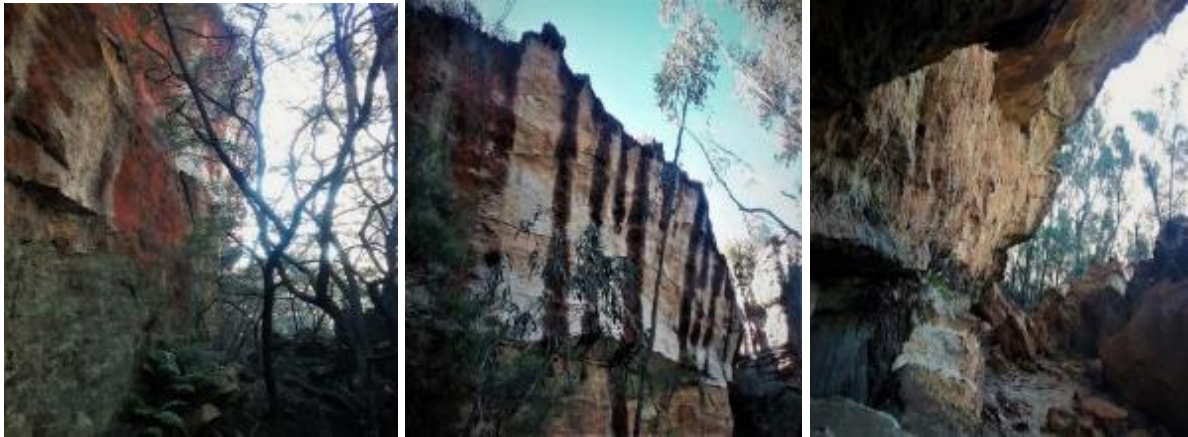
Photos: State Mine – cliff falls and surface fractures in the State Mine Airshaft No. 3/Lost City area – 17 July 2019

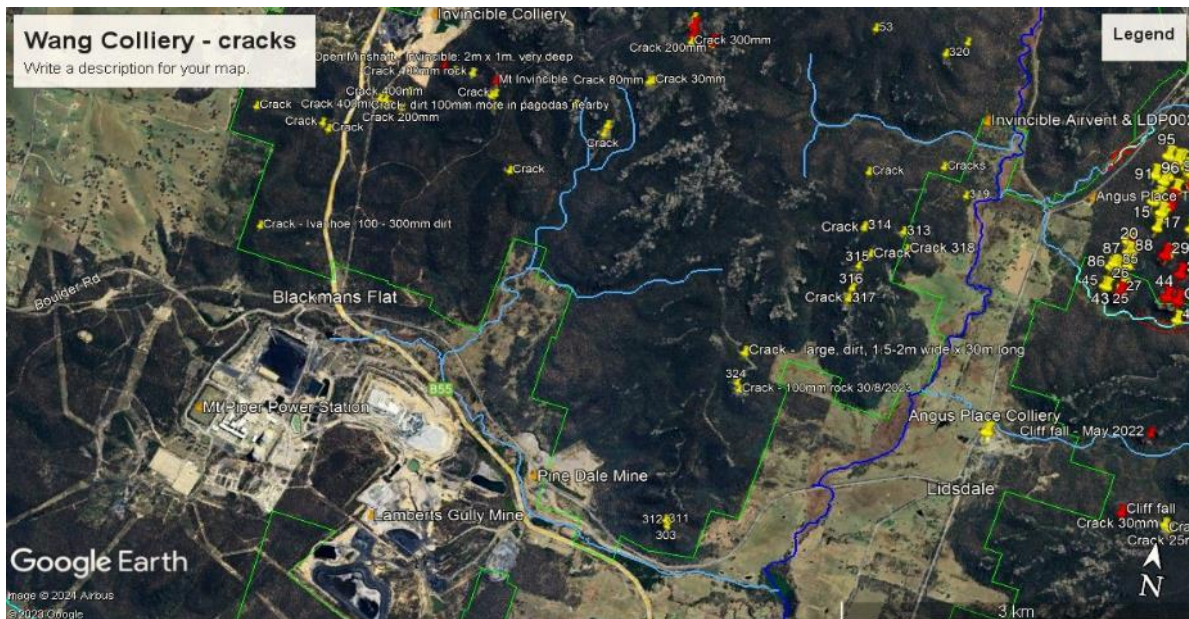
A Bord & Pillar mine in Blackmans Flat from around 1923 until 1982. LEG has recorded many surface cracks above the mine (see Google Earth map below), one of which is the largest LEG has ever recorded in the Lithgow area at over 2m wide. In response to residents concerned about subsidence risks from the Angus Place West proposal, Centennial confirmed that cracks observed at Site 4 were located above the Wallerawang Colliery. "The crack widths typically vary up to 0.5 m; however, some cracks have also undergone weathering and fretting and have overall widths and steps greater than 1 m." (MSEC letter to Centennial, Angus Place Colliery – potential surface impacts, 24 November 2022).

Figure: Mine subsidence cracks (Yellow Placemarks) recorded by LEG above bord & pillar workings of Wallerawang Colliery
