# Lithgow Environment Group Inc.

11 September 2024

## **RE: CENTENNIAL CLARENCE COLLIERY – MINE SUBSIDENCE DAMAGE**

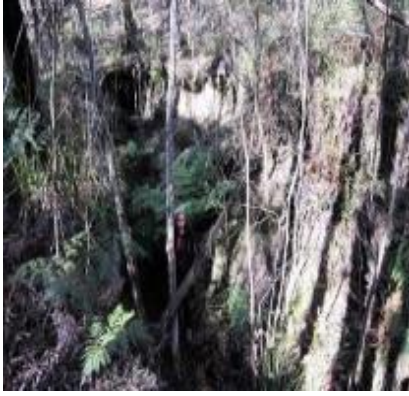
First recorded July 2010, last sighted April 2024. Large sinkhole 200m long x 10m wide x 2m deep with a 150-250mm wide subsidence crack at its eastern end. The crack runs east-west across a northerly flowing tributary of Bungleboori Creek. All surface water that once flowed down this creek now flows down that crack, and the creek and THPSS downstream are totally dry. Groundcover vegetation has not recovered in 14 years of observation, with many bare and denuded areas.

Photo 4: Site 1 Sinkhole – July 2010

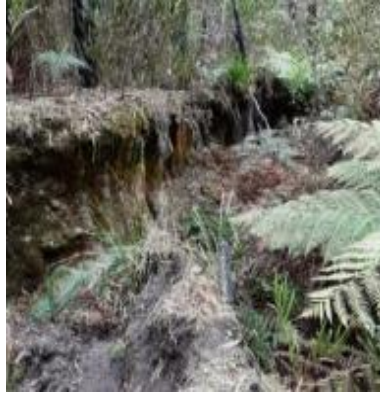
Photo 5: Site 1 Sinkhole – June 2024

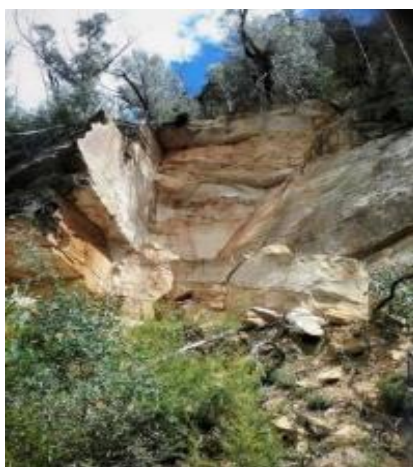
Recorded by LEG on 9 March 2018. The Clarence Colliery 2016 End of Year Report states that Panel 912 was approved on 7 June 2016 as part of the 900 Area Variation 3. The EPBC Referral for Clarence Colliery Panels 918-920 stated “the proposed action is not expected to result in any measurable direct or indirect impacts to geodiversity values (ie clifflines)”. Really??? (see also Site 18 & 19)

Photo 29: Cliff collapse - Panel 912

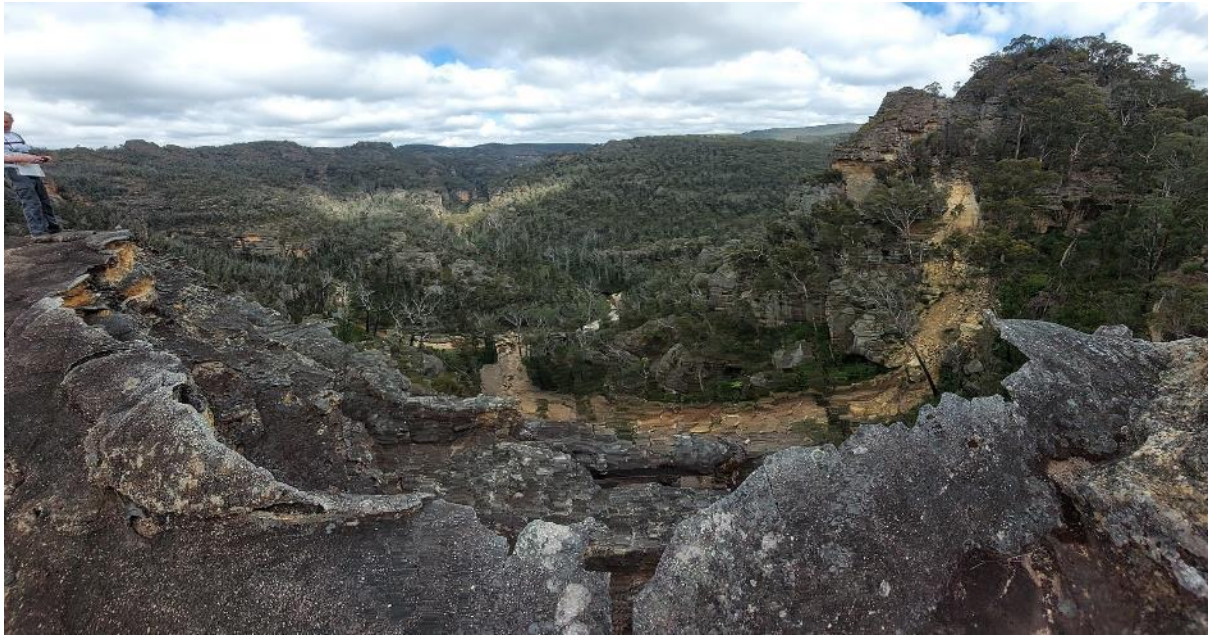
Photo 72: Cliff fall in GBMWA – Courtesy of the Bush Explorers, Yuri Bolotin and Brian Fox – 19 August 2024

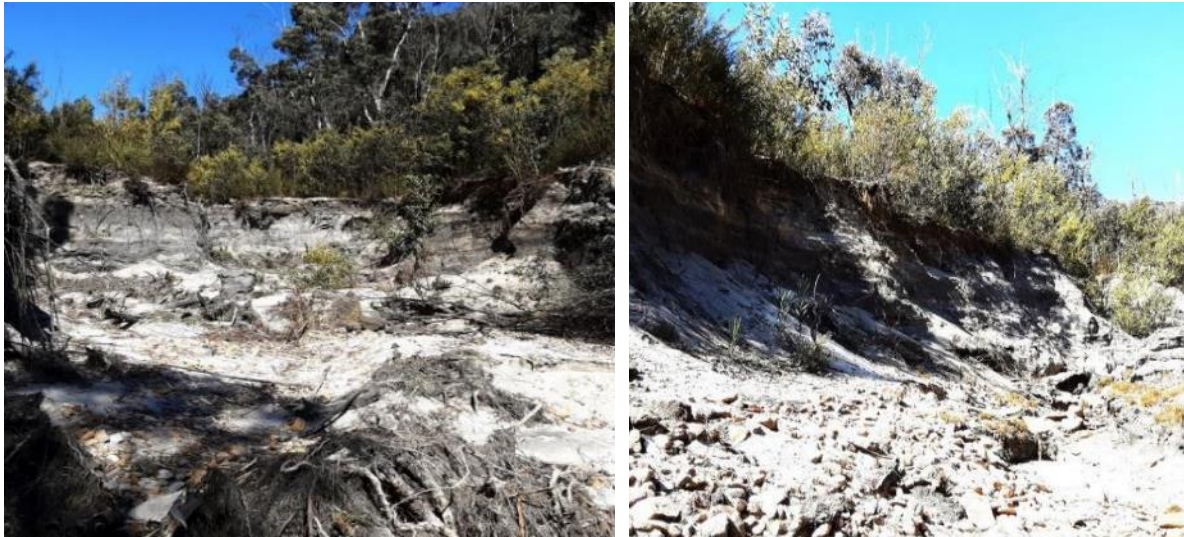
This is the most severe channelisation and erosion LEG has seen on Newnes Plateau. The most recent damage is clearly visible on Google Earth, extending for 200m and up to 20m wide x 4m deep. It corresponds almost exactly to where Panel 314 passed underneath this creek. Remnant *Olearia quercifolia* and other swamp species suggest THPSS or Hanging Swamps once occurred pre-mining.

Photo 78, 79: Clarence Colliery Panel 314 – relatively recent severe channelisation, erosion, slumping, dry creek

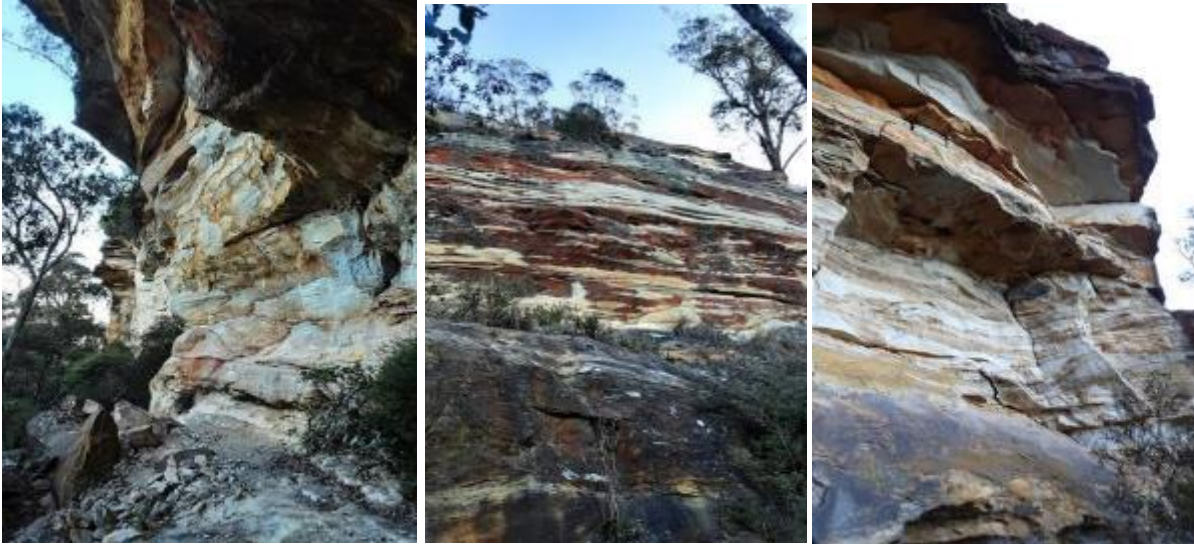
*Photo 10, 11, 12: Hassans Walls cliff falls - Undercliff Track – photos taken 1 July 2023*

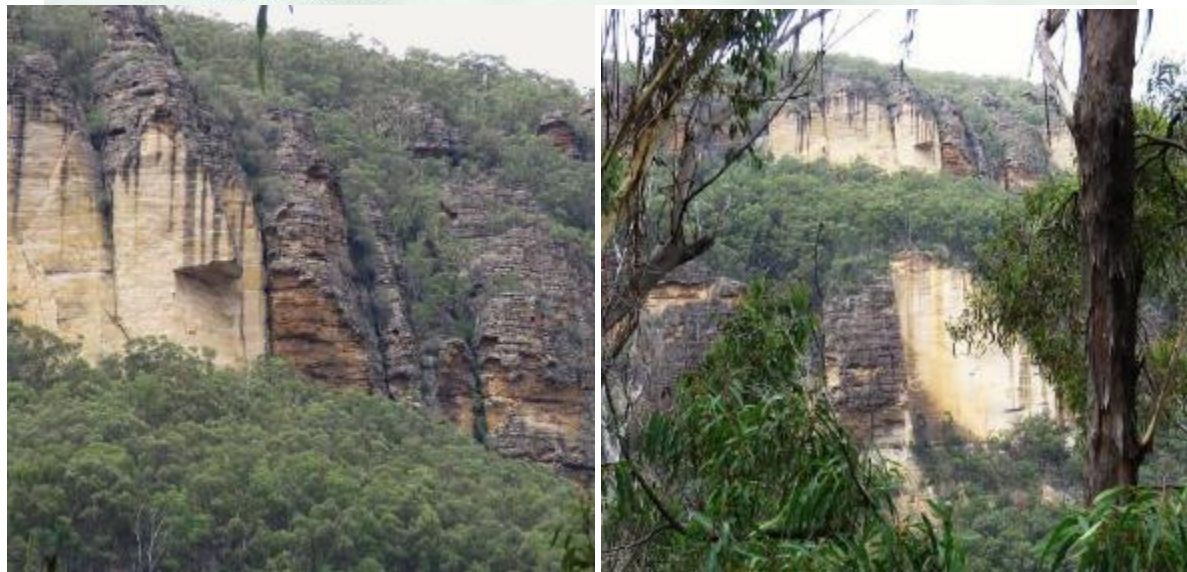
The earliest recorded cliff falls due to Bord & Pillar mining in the Lithgow region occurred c1910 at Newnes Shale Oil Mine in the Wolgan Valley. Four cliff falls can be seen above the old industrial ruins.

*Photos: Old photo (top) on display at the Newnes Hotel c1910. Cliff fall photos taken 27 February 2015.*

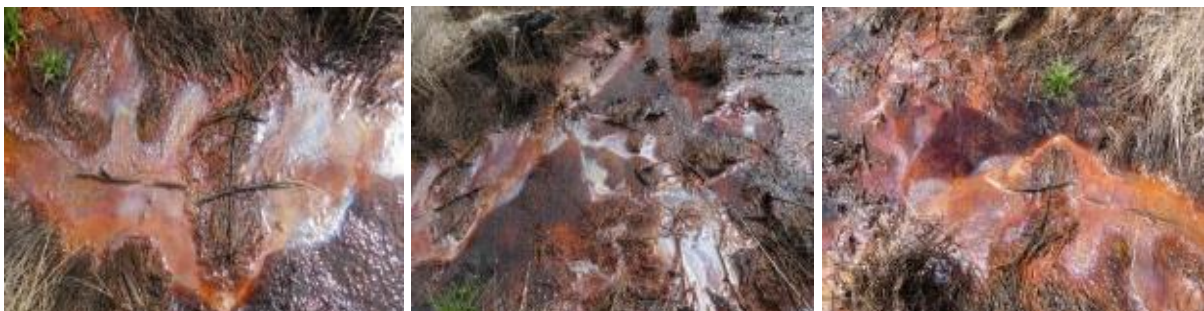
At both sites LEG recorded a salinity of 1600uS/cm (natural background levels are 30uS/cm), pH level of 4 (very acidic), and low Dissolved Oxygen level of 3.0 mg/L (healthy local streams are around 8 mg/L.)

Photos: Seepage from Tyldesley Mine/Cullen Valley Mine - Acid Mine Drainage/Saline Drainage – 12 September 2014

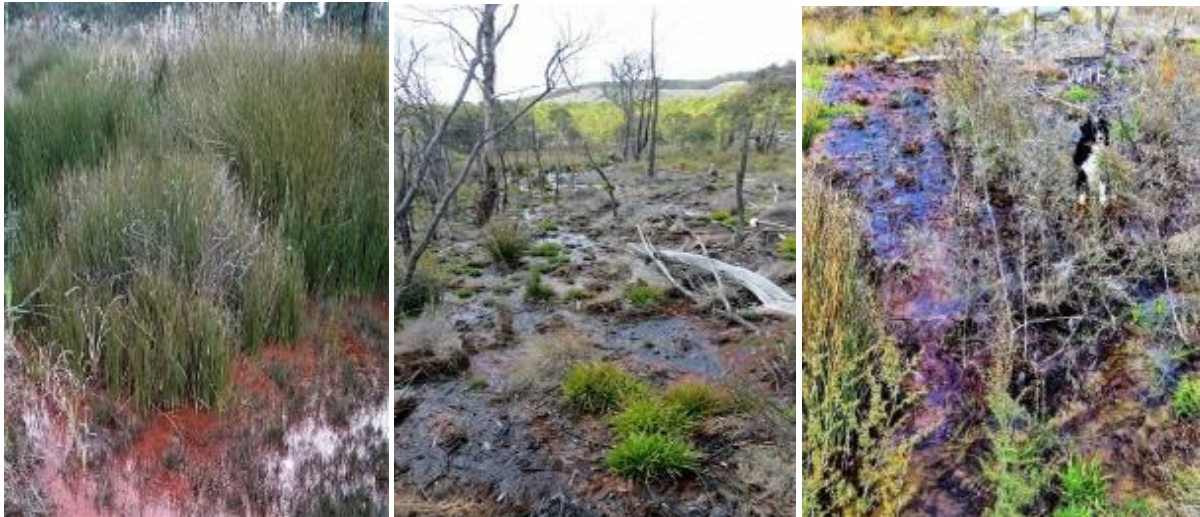
*Photos: Seepage from Tyldsley Mine/Cullen Valley Mine - Acid Mine Drainage/Saline Drainage – 12 September 2014*
