# Lithgow Environment Group Inc.

11 September 2024

## **RE: CENTENNIAL CLARENCE COLLIERY – MINE SUBSIDENCE DAMAGE**

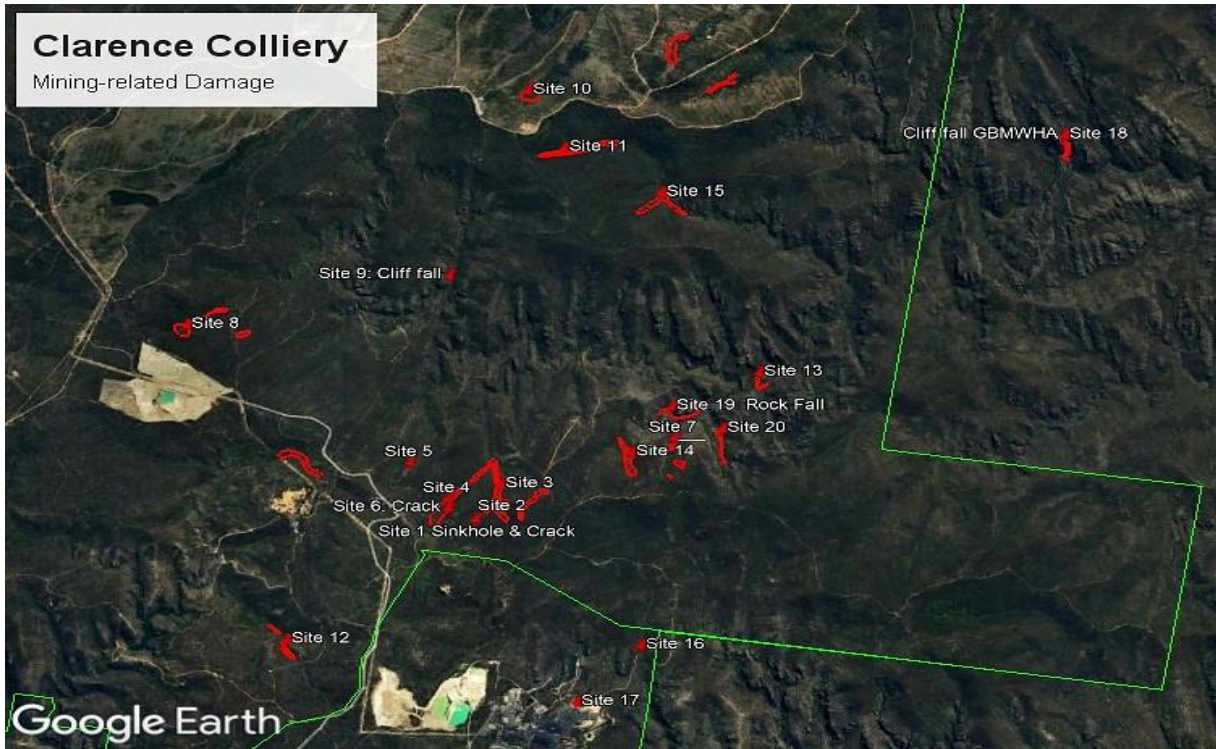
Figure 1: Mining-related damage – Clarence Colliery. Location of sites referred to below.

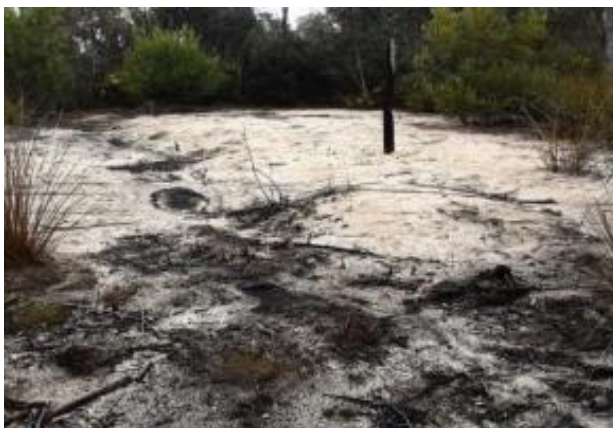
First recorded July 2010, last visit April 2024. Clearly visible on Google Earth. A silt-plug about 20m x 10m in a dead THPSS with a dry creekbed. After 14 years this creek remains completely dry, and the swamp remains bare. All this silt will eventually end up in Bungleboori Creek and the GBMWAH.

Photo 9: Site 3 Silt plug - June 2024

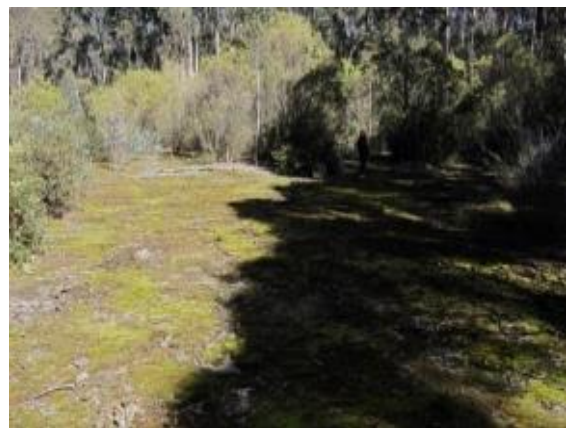
Photo 10: Site 3 Moss was the only vegetation in July 2010

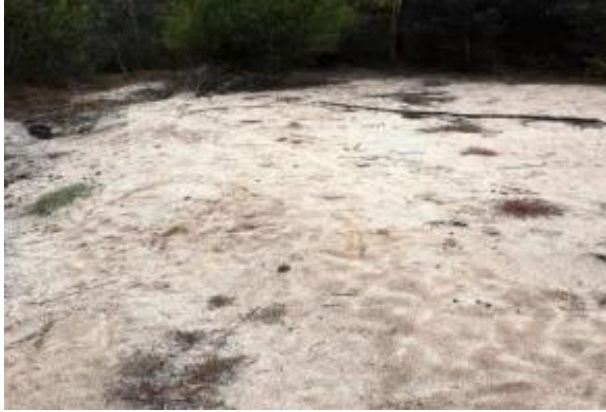
Photo 11: Site 3 All this unstable silt will end up in GBMWHA

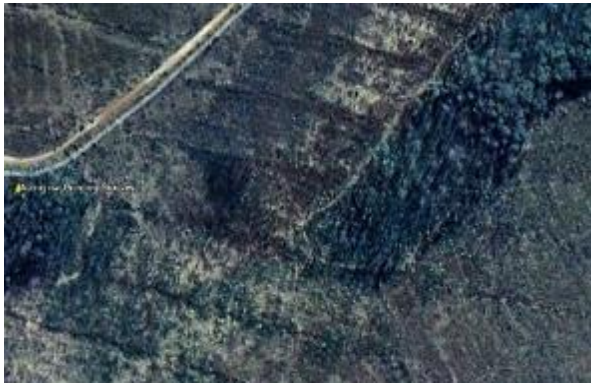
Google Earth Imagery showed intact vegetation east of the Aboriginal grinding groove site off Waratah Ridge Road in July 2021, yet in August 2023 vegetation die-back was clearly visible. A dramatic drying event had occurred. The only disturbances in this area between 2021 and 2023 were Mustard Gas removal (didn't occur near this swamp) and mining of Clarence Colliery Panel 906 or possibly headworks for Panels 908 & 910. Groundwater levels may have been lowered to facilitate mining.

Photo 30: Site 10 Google Earth Imagery July 2021

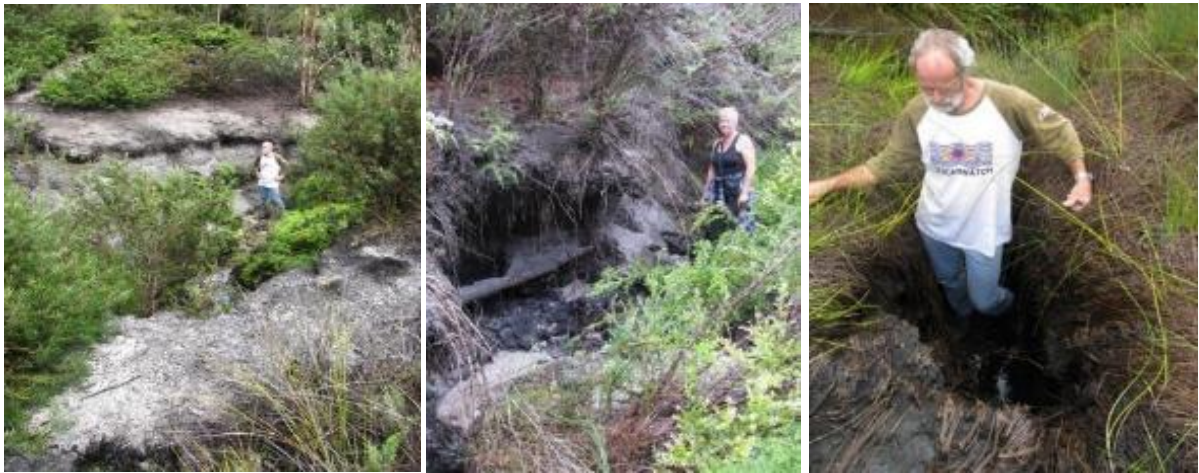
*Photos 37, 38, 39: Site 12 – Erosion, channelization, slumping downstream of Clarence Transfer discharge – 31 January 2010*

The Sydney Catchment Audit 2010 included Recommendation 9: *Lithgow City Council & Centennial Coal should ensure that water transfers from the Clarence Water Transfer Scheme are piped around, rather than flow through, Farmers Creek Swamp.* The Federal Government provided \$4 million in funding.

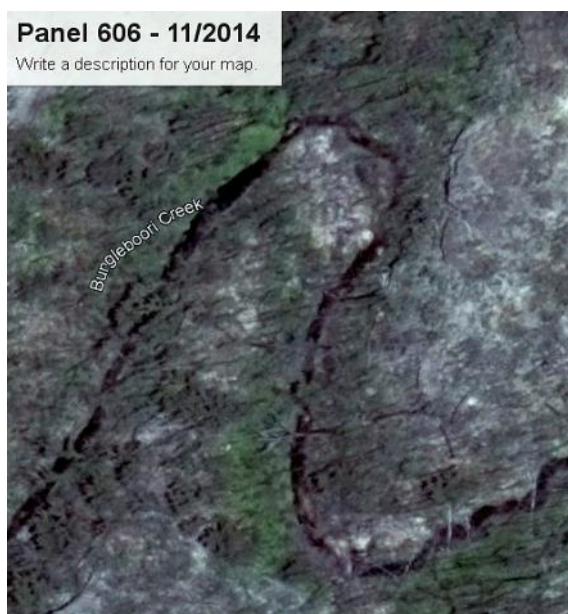
GoogleEarth imagery in November 2014 (after the October 2013 State Mine Fire) shows the stream path of Bungleboori Creek at the southern end of Clarence Colliery Panel 606 as being intact. In September 2024 (after December 2019 Gospers Mountain Fire) it was significantly disturbed.

Photo43: Google Earth Imagery 11/2014

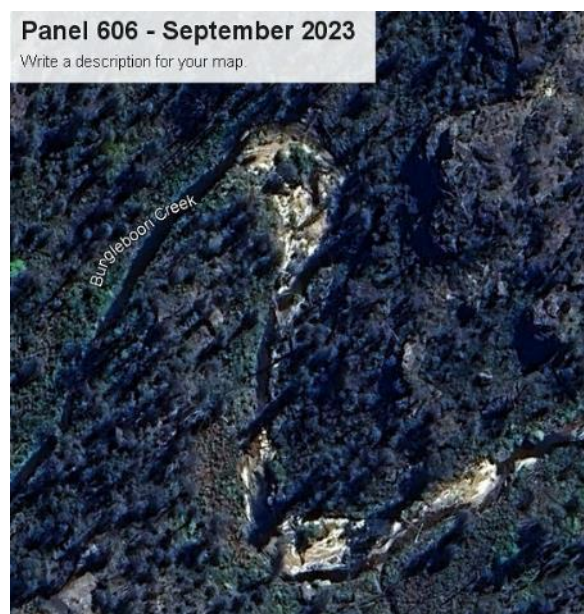
On inspection it appears that Bungleboori Creek has changed course in a more easterly & southerly direction. LEG believes this is not fire-related. Undermining of Bungleboori Creek by Panel 606 has likely resulted in subsidence altering the slope of the land surface and tilting of the creekbed.

Photo 44: Google Earth Imagery 09/2024

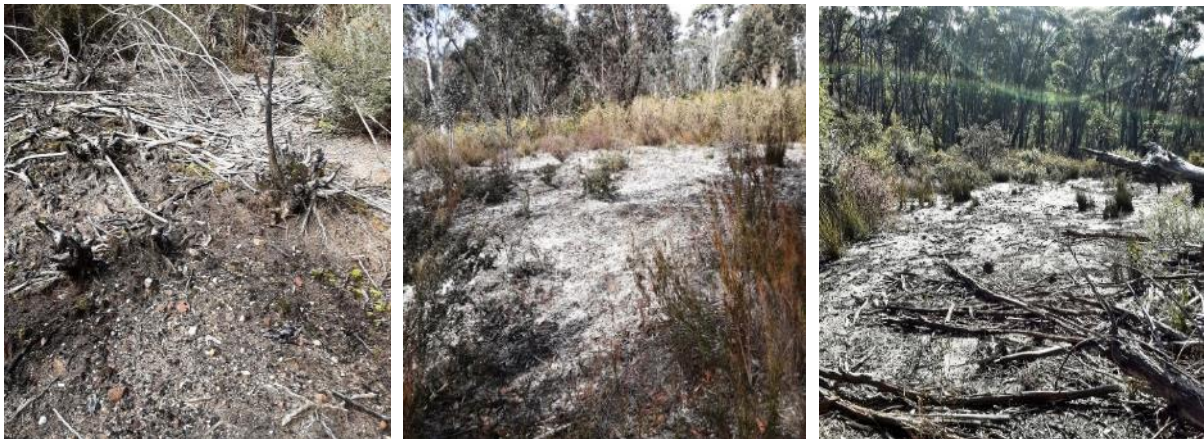
Several dead hanging swamps occur in this area, the creekline is dry and desiccated, and an arm of Bungleboori Creek downstream is totally dry. Whilst inspecting this site LEG recorded the threatened species *Pultenaea glabra* (EPBC Act - Vulnerable; NSW BCA - Vulnerable), not previously reported by Centennial as occurring in the Clarence Colliery Mine Lease. This raises serious questions about the adequacy of Centennials recording/reporting of Threatened Species at risk to its mining operations.

Photo 56-58: Site 15 Dead Hanging swamps, dry and desiccated creekline, dry creekbed downstream

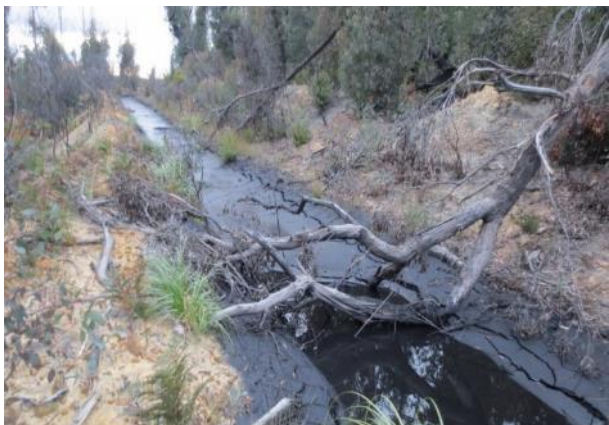
On 2 July 2015 part of the eastern wall of Reject Emplacement Area (REA) 3 failed resulting in the release of coarse reject and 2,330 tonnes of coal fines into the Wollangambe River & GBMWHA. The Land & Environment Court convicted Clarence Colliery P/L of two offences and imposed financial penalties totalling \$1,050,000 plus \$106,010 in investigation and legal costs - the single largest fine following prosecution by the EPA.

Photo 62-69: Clarence Colliery Reject Emplacement Area ("REA") 3 – collapsed on 2 July 2015

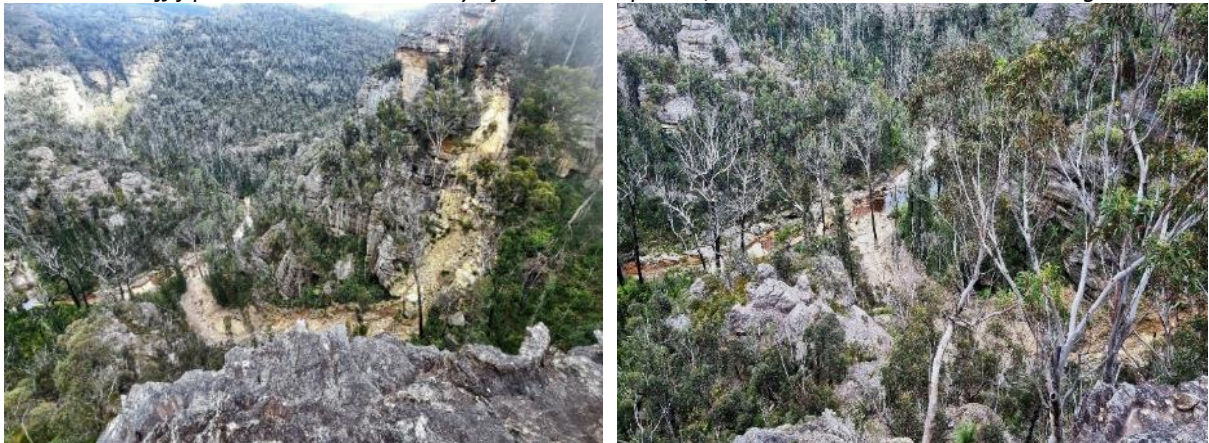
Photo 73-74: Cliff fall in GBMWA east of Clarence Colliery Panels 611A & 611B – 19 August 2024

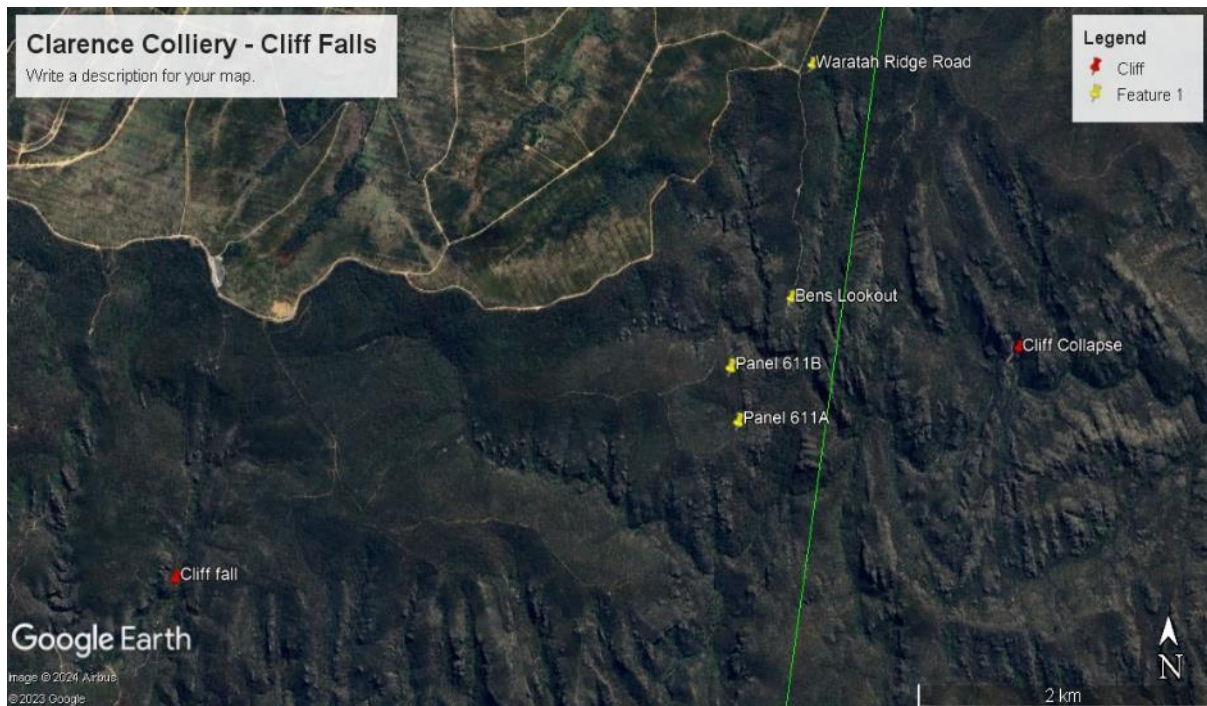
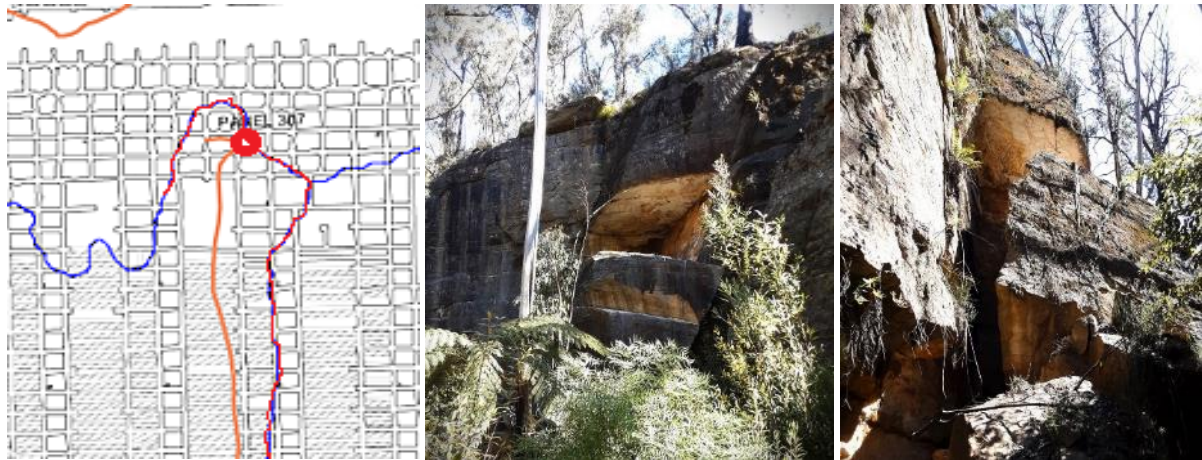
Recorded 4 September 2024. Appears to be a relatively recent rock fall. The creek (a tributary of Bungleboori Creek) in this vicinity has also dried up, both upstream and downstream.

Figure 4: Rock fall (red dot), dry creek

Photo 74 & 75: Site 19 Panel 307 – Rock fall and dry creek

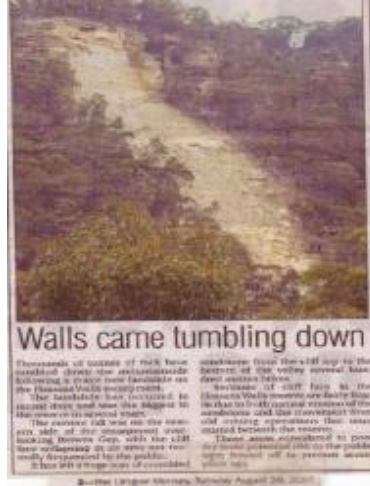
Photo 2: Lithgow Mercury 28/7/2007

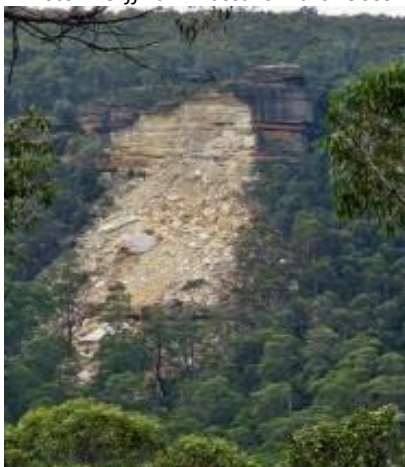
Photo 4: Hassans Walls – March 2015

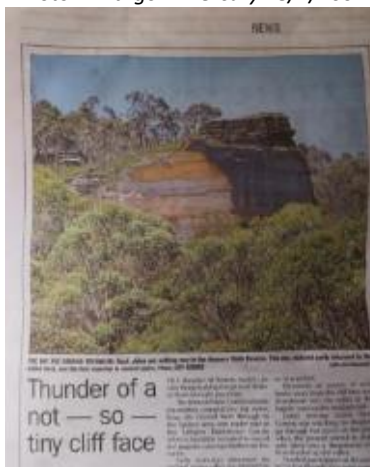
Photo 5: Lithgow Mercury 10/3/2015

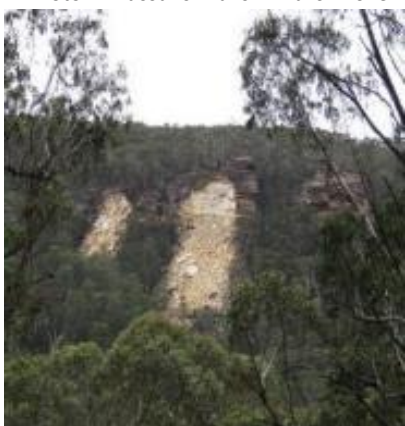
Photo 7: Hassans Walls – 20 June 2015

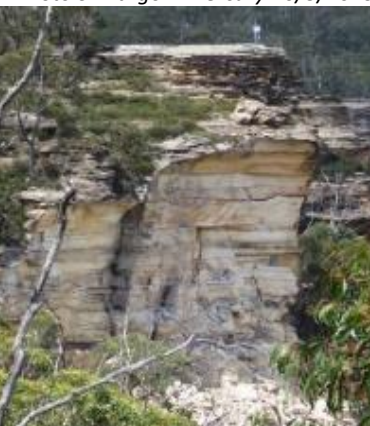
Photo 8: Hassans Walls – 20 June 2015

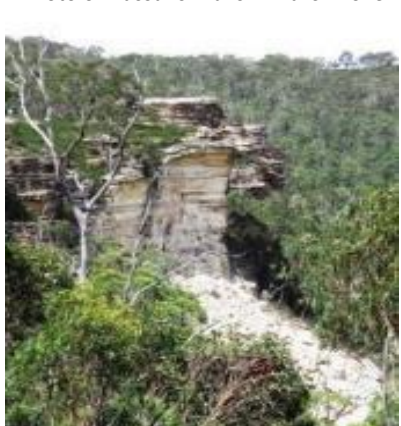
Photo 9: Hassans Walls 20 June 2015

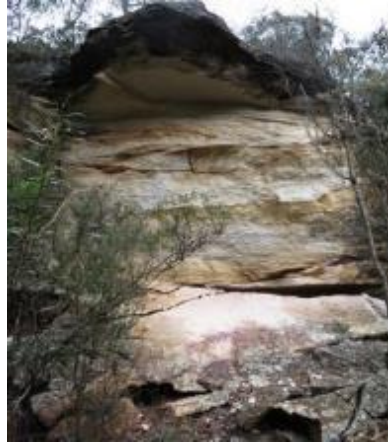
Photo: Cliff fall Invincible 9 August 2009

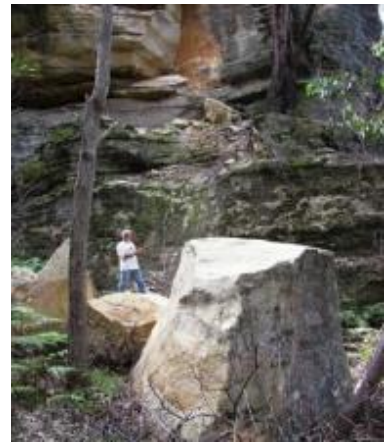
Photo: Cliff fall Invincible 9 August 2009

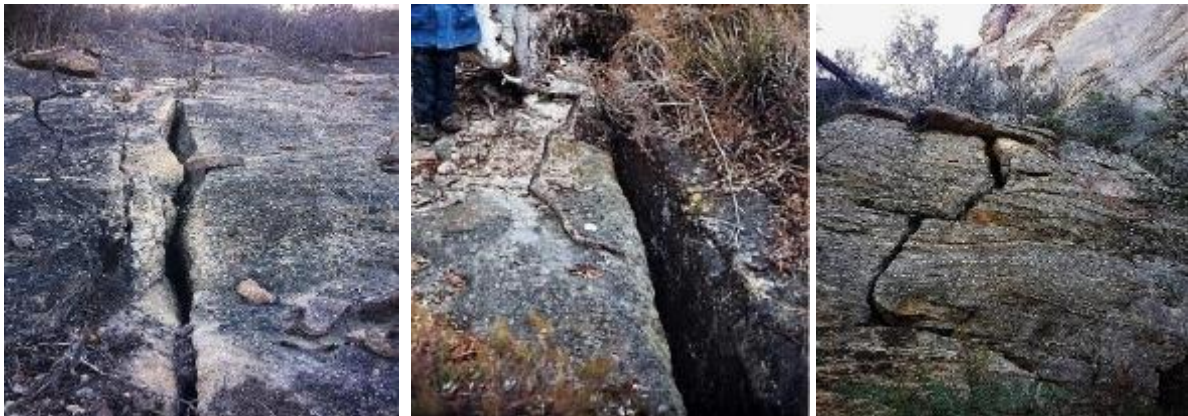
Photos: State Mine – cliff falls and surface fractures in the State Mine Airshaft No. 3/Lost City area – 17 July 2019
